WARFFUM INCIDENT, 31th May 2005

Jakob van der Wal

Process Safety Conference

INVESTIGATION RESULTS AND FOLLOW-UP

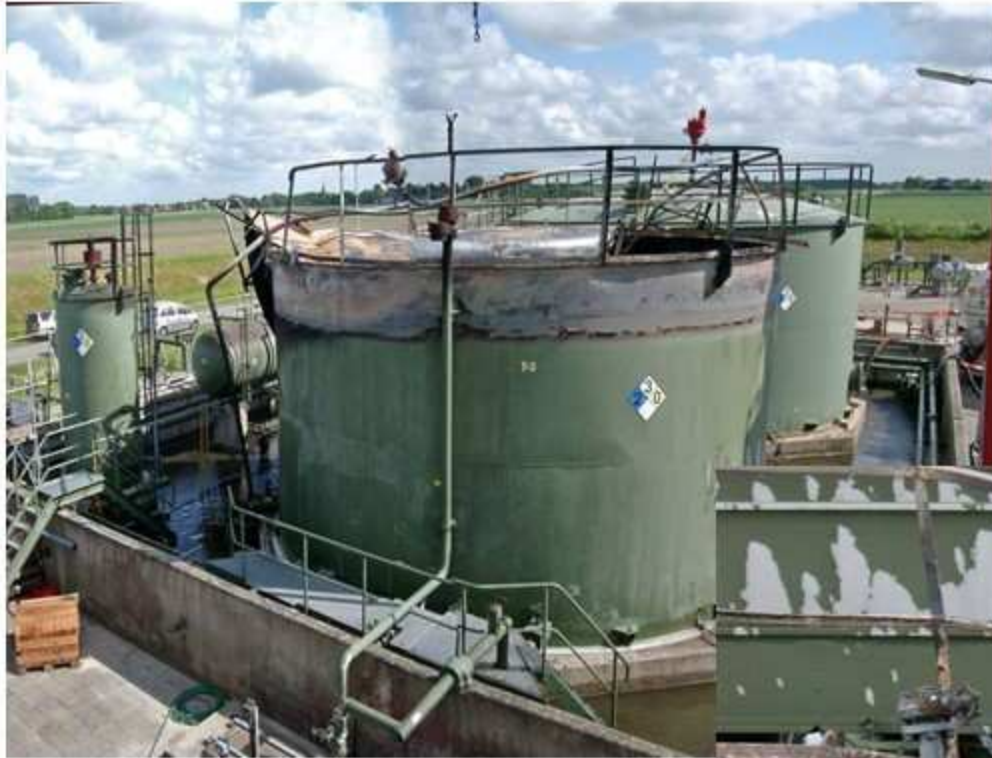
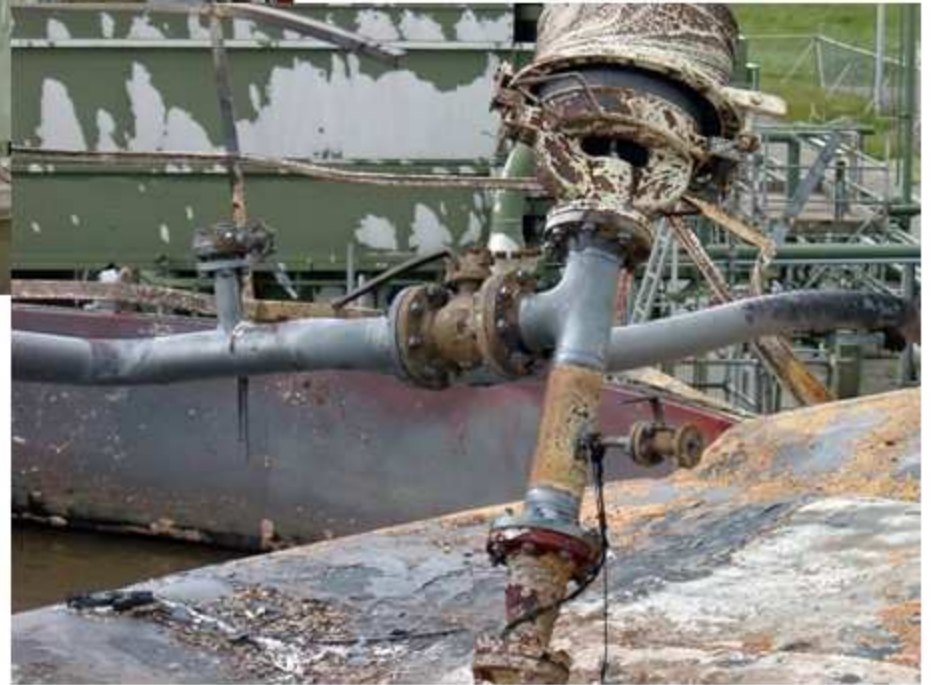
TANK T3 AFTER THE EXPLOSION

- Time and date : 31st May 2005 09:00
- Executed work : Installation of a Vapour Recovery System (VRS) on the roof of Tank T3
- Two fatalities
- One injured person

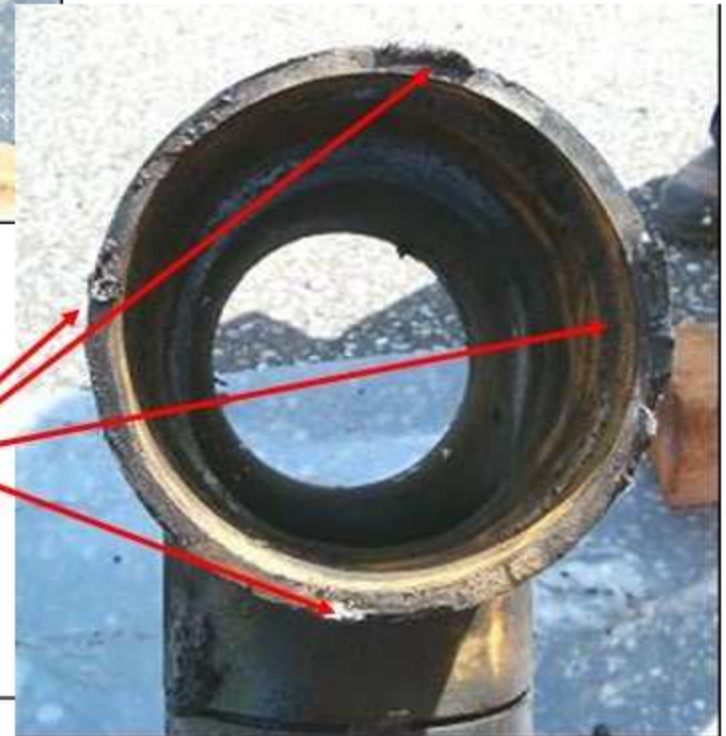
Remains of tack welds

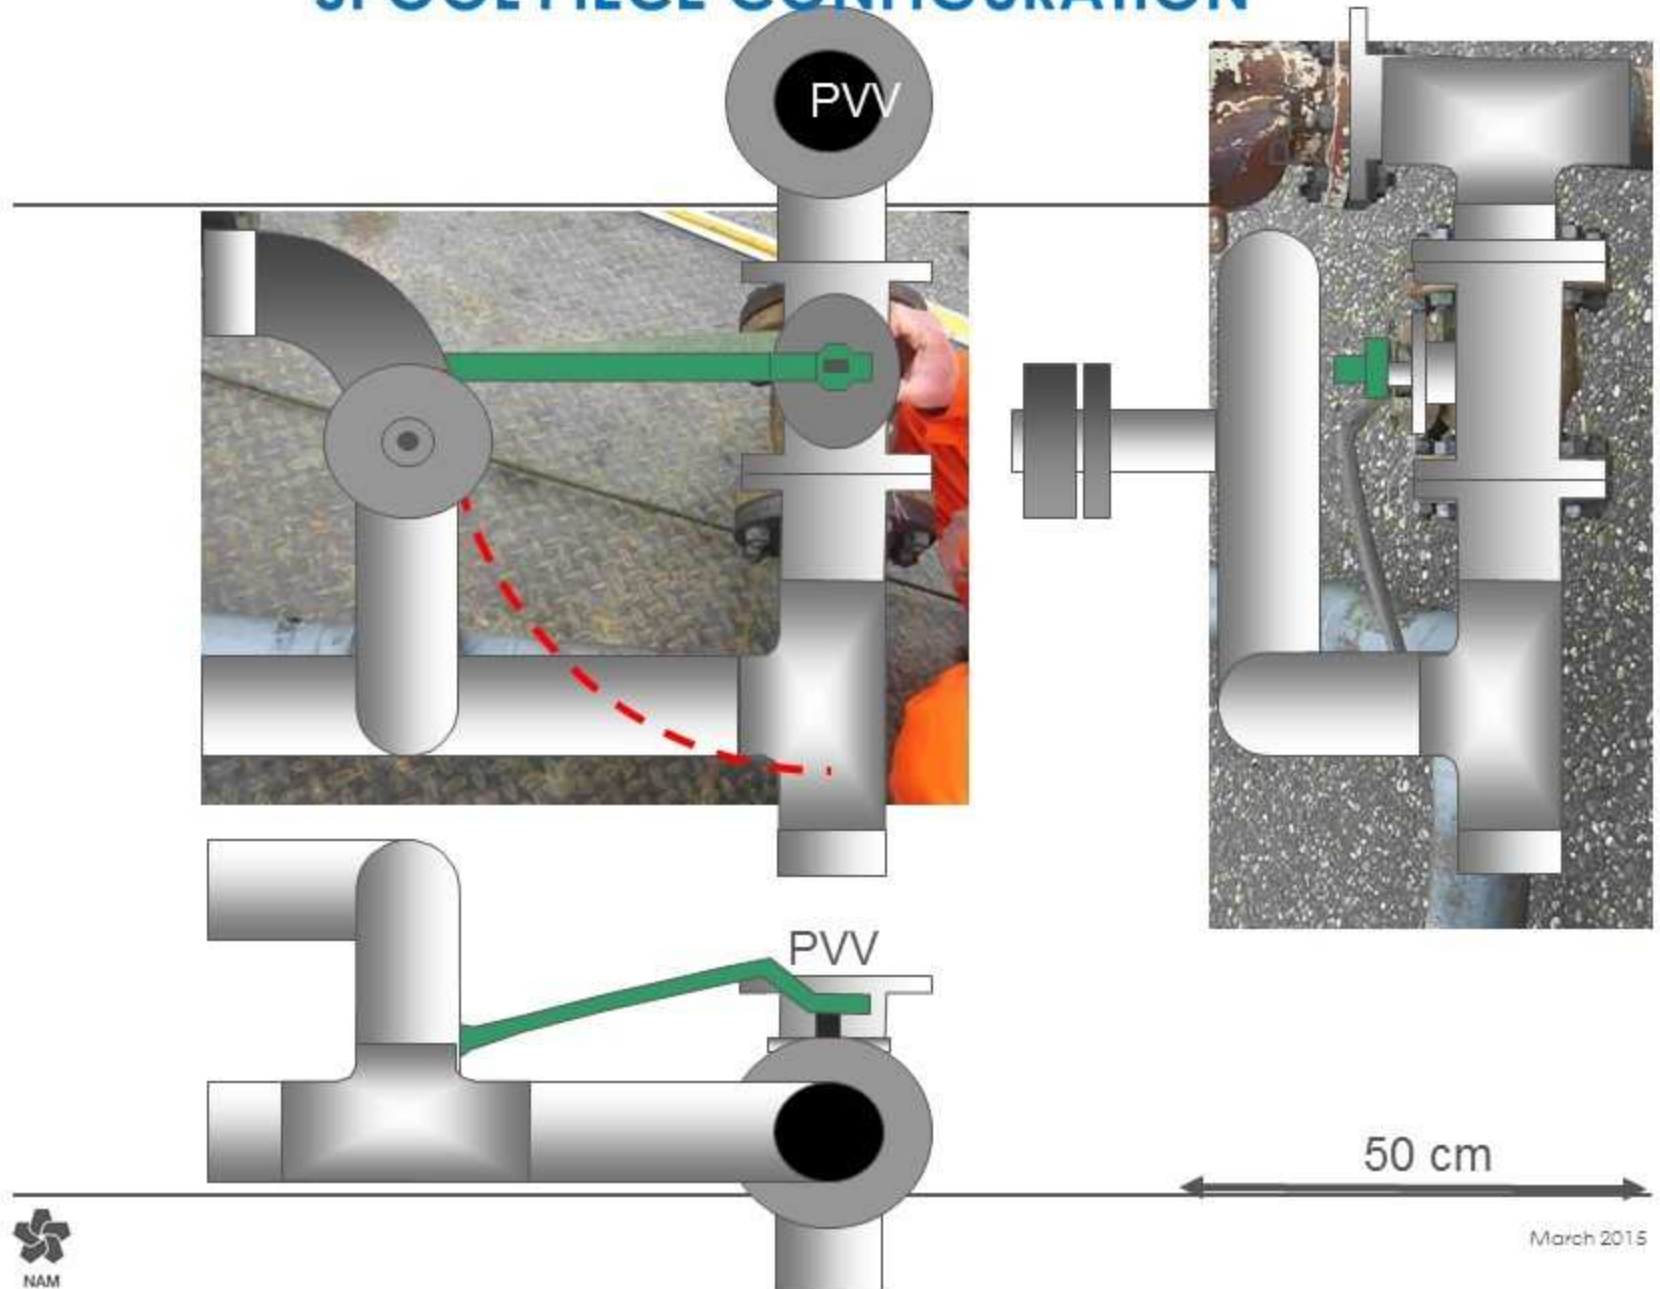
SPOOL PIECE CONFIGURATION

Hot work on 4" gas blanketing line in Zone 0 of roof tank T3
