Protection from Hazards – Human behaviour

DuPont Belle incident

The failure- chronology of events

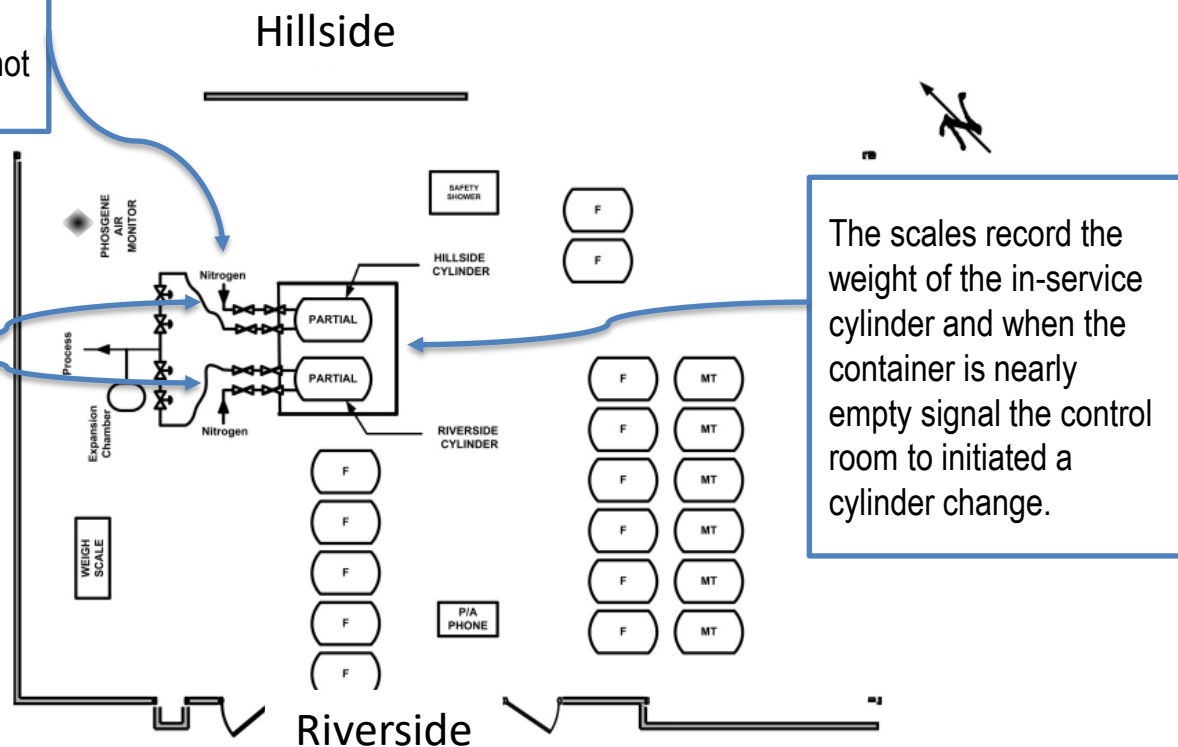
The scales record the weight of the in-service cylinder and when the container is nearly empty signal the control room to initiated a cylinder change.

Figure 12. Phosgene shed and full (F) and empty (MT) cylinder locations on day of incident (not to scale)
