Explosion

During high pressure water cleaning

May 5-6 2022

Westlake

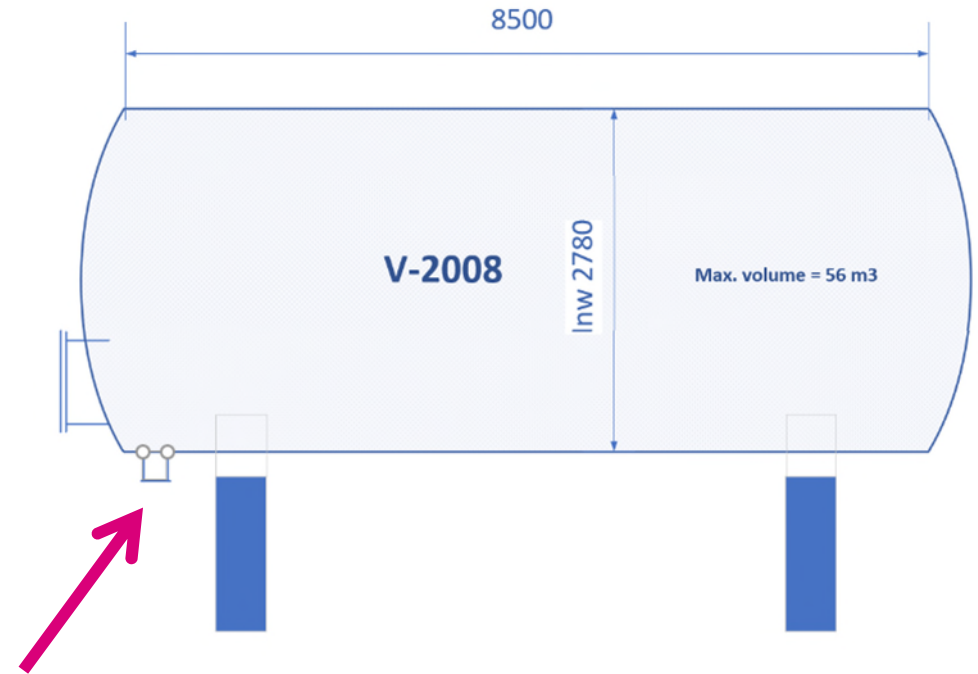
IPE vessel V2008

- Purpose : Buffering and separation of Isopropyl ether/water
- Volume : 56 m³
- Design pressure : 3.5 bar(g)

Work: Repair bottom nozzle -> Preparation for cleaning V2008

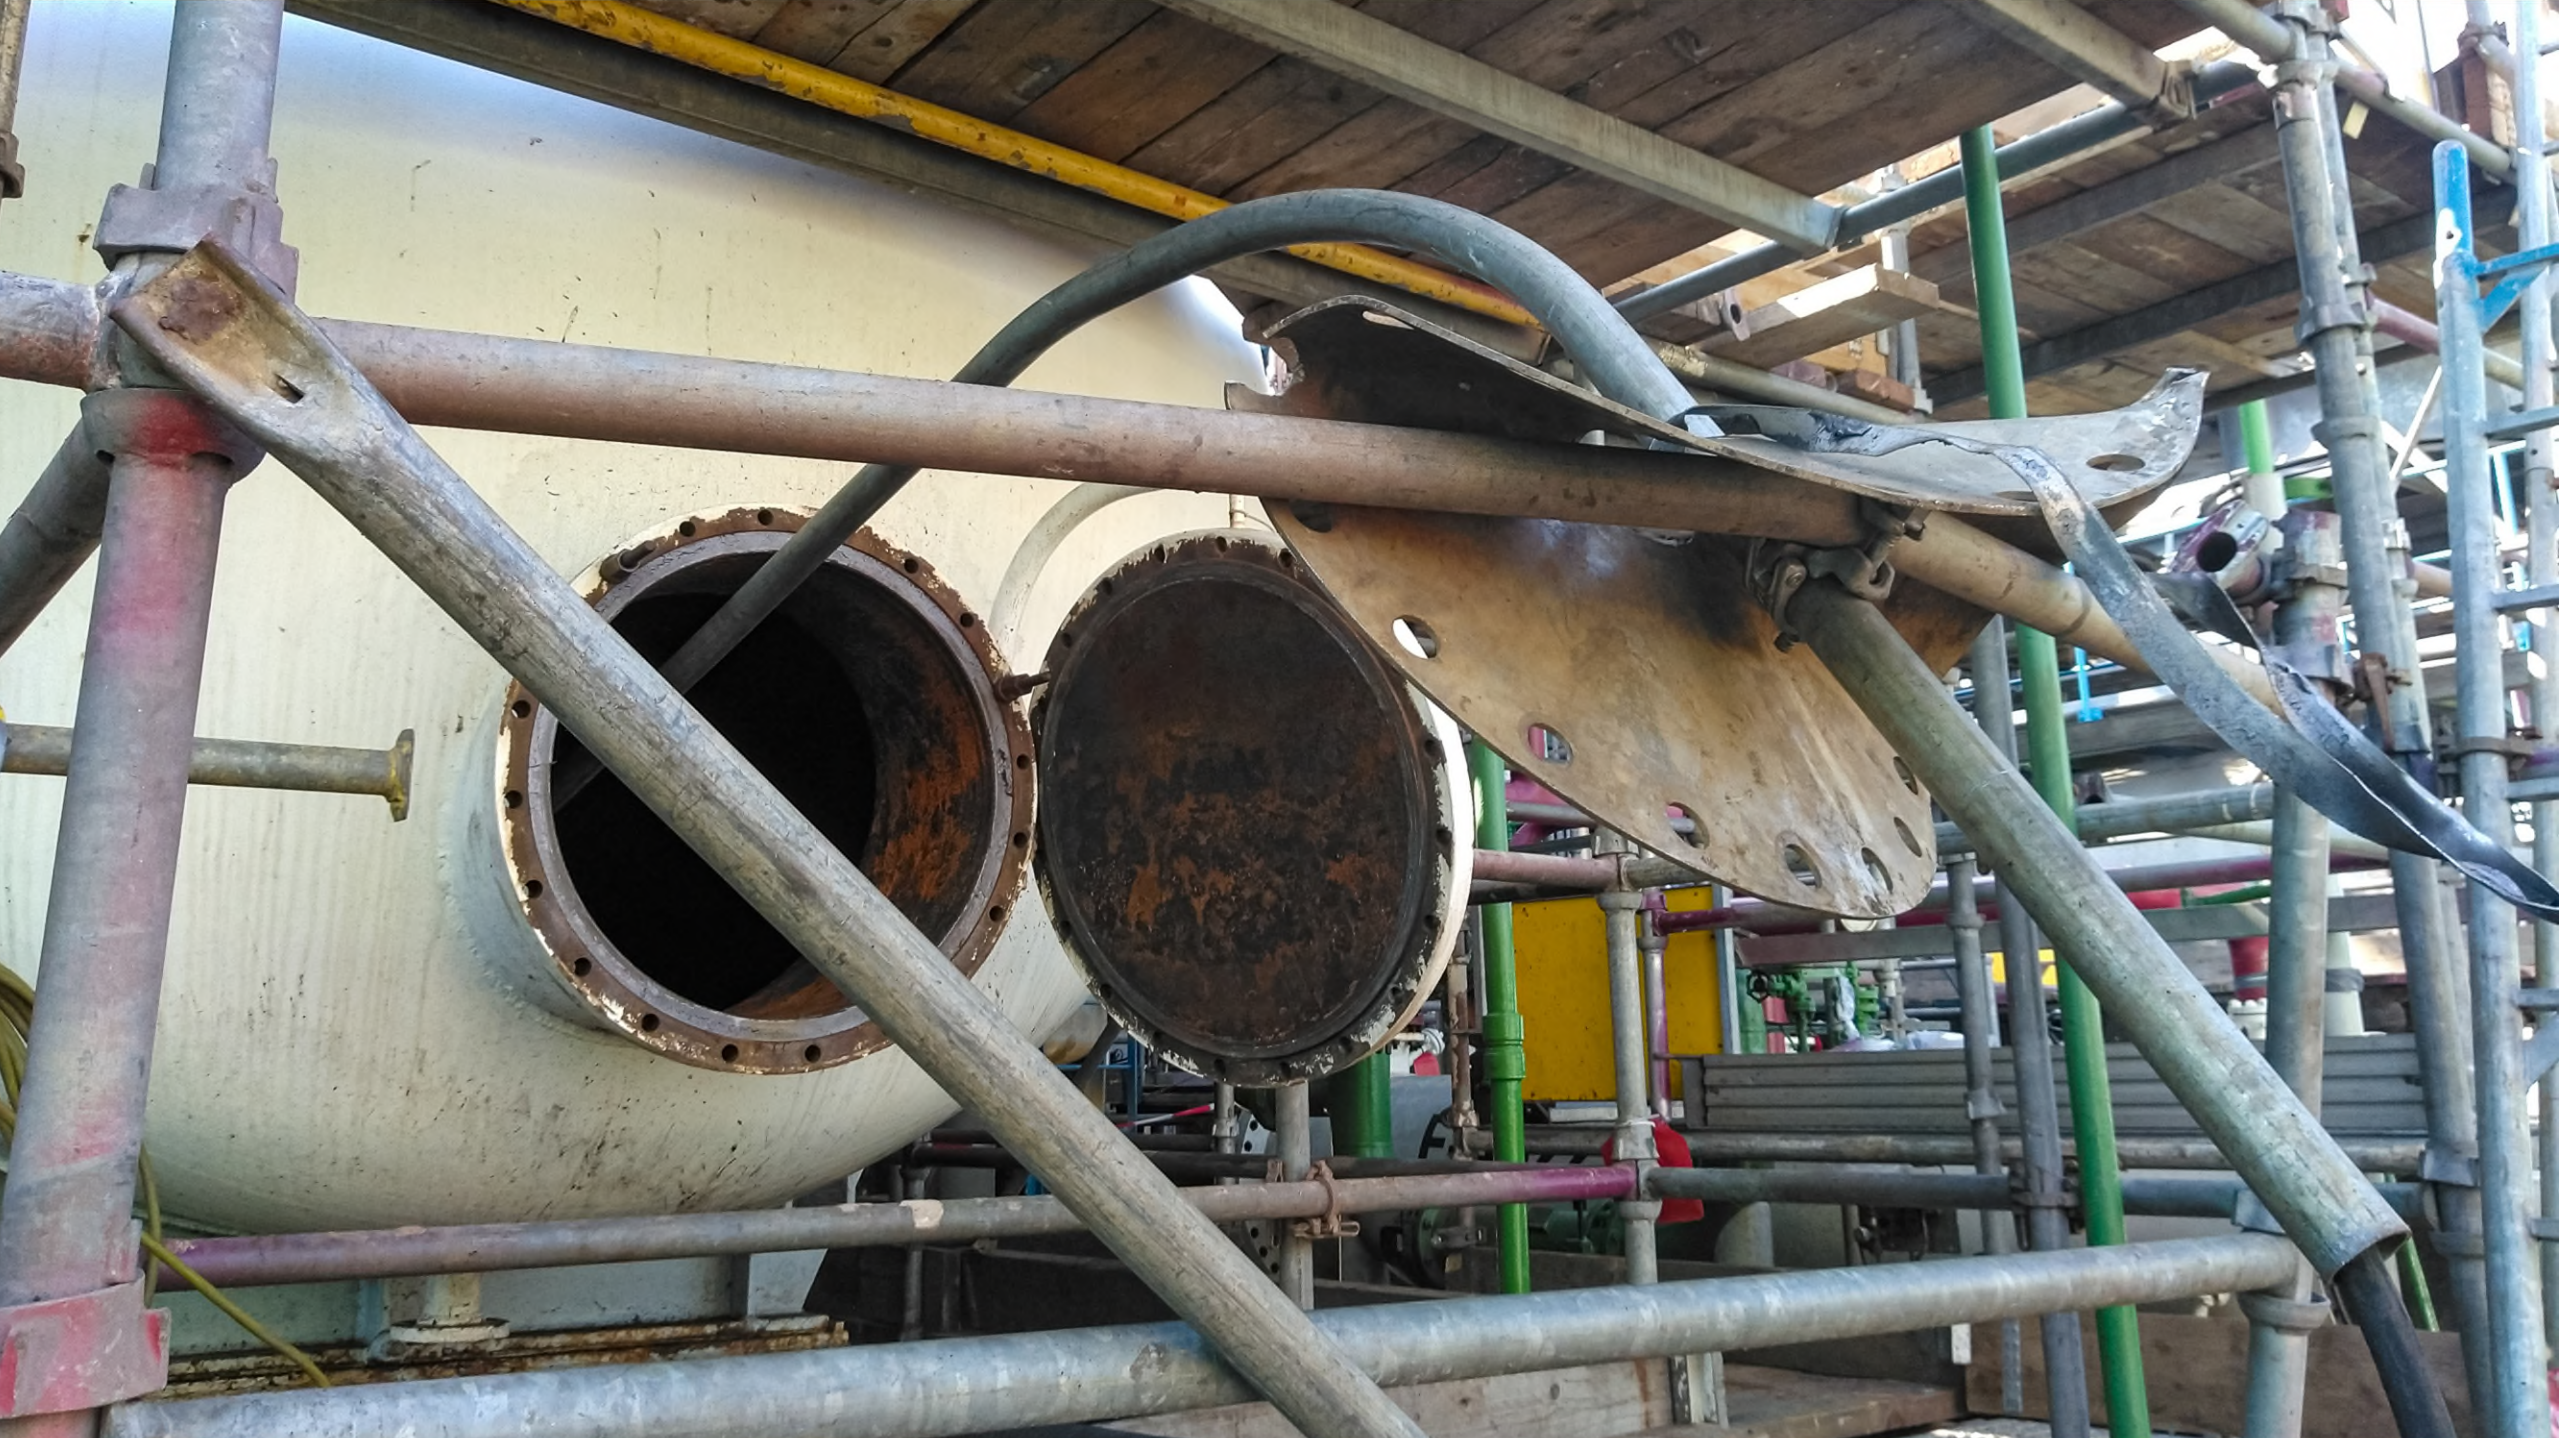
- After 15 minutes loud 'bang'
- Flame of 4-5 meter was seen
- Butterwash pipe was bent
- Splash plate fully bent over scaffolding pipe
- Hard hat blown from head contractor
- Two PE drain drums under nozzle fell down/blew away
- Rolling scaffold damaged pipe insulation

*Position
Contractor
personnel*

*Pressure wave ext.
(between ~1-25
mbarg)*

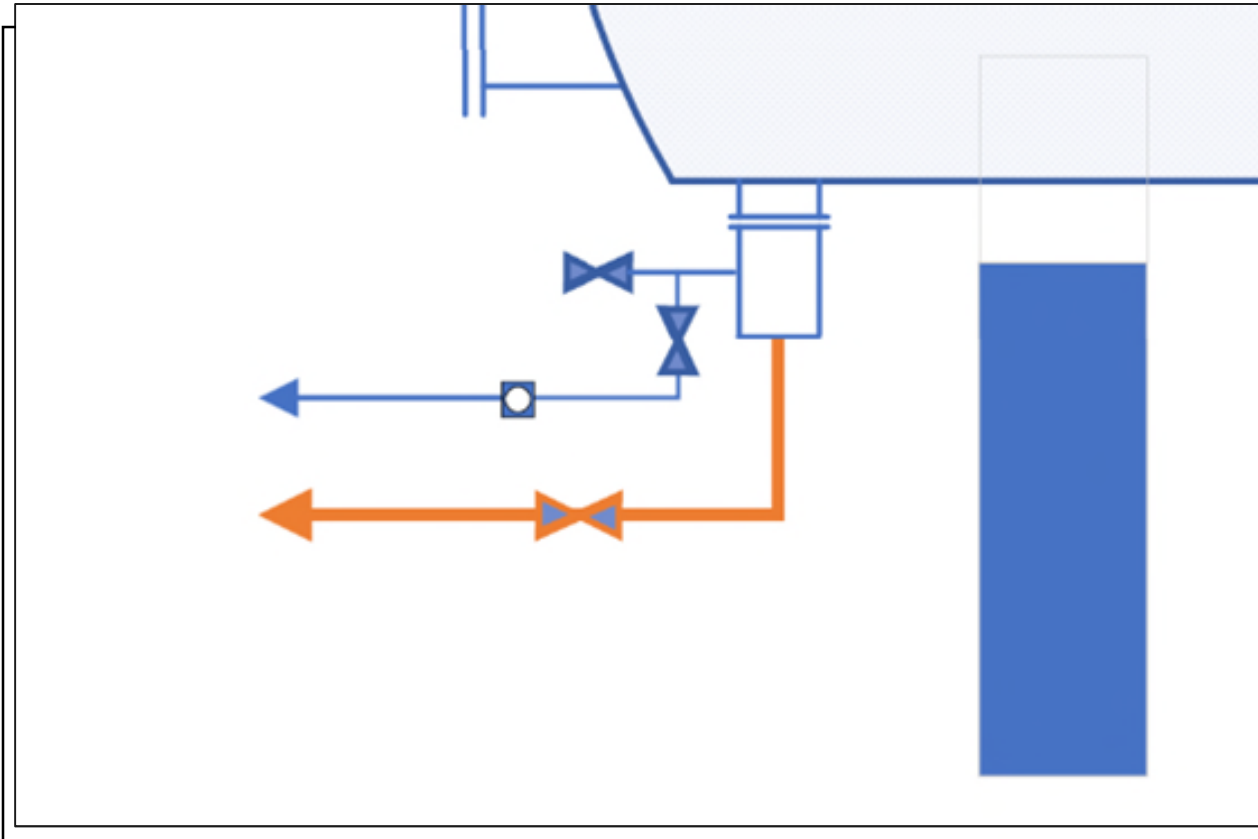
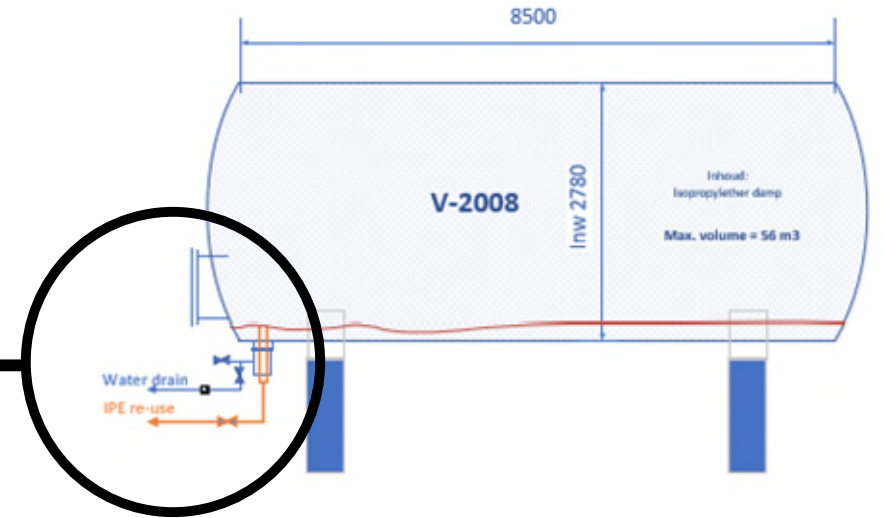
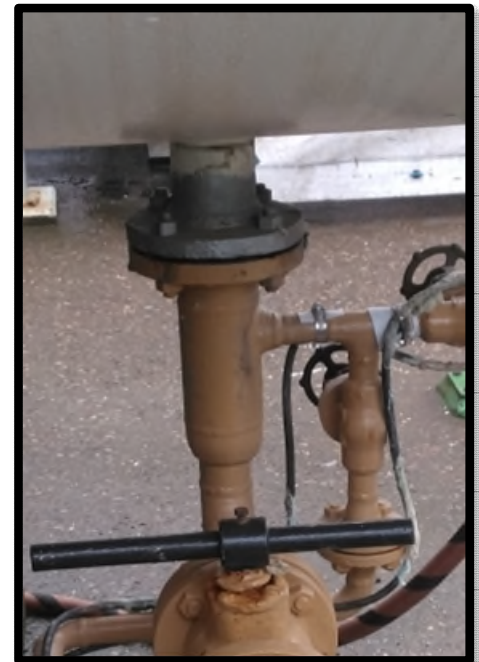
Design configuration

Initially ~2 m³ of liquid IPE remained behind, but was removed at a later stage (after steam out)

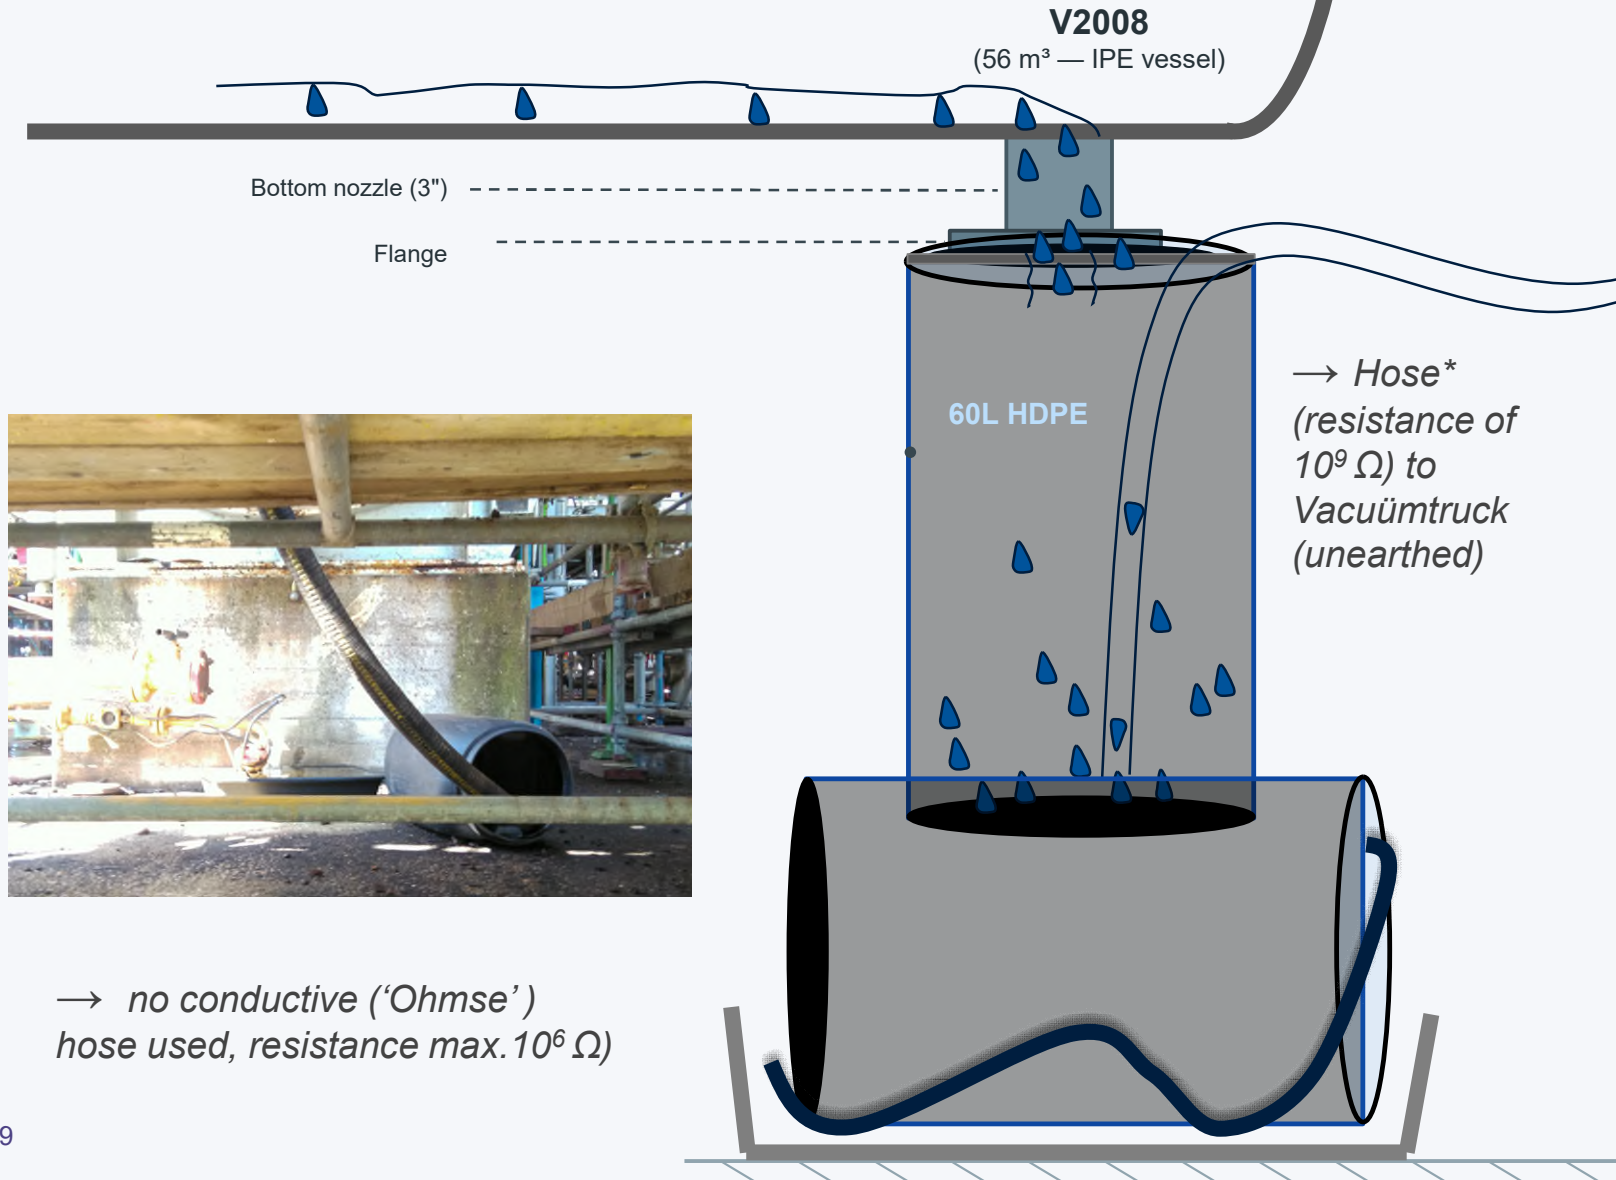
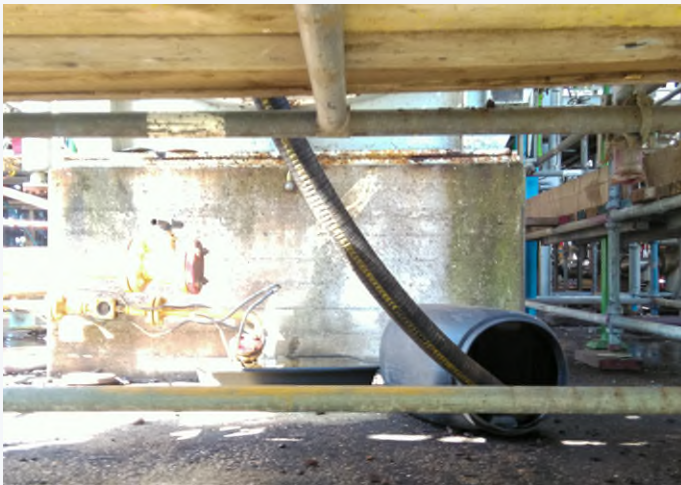
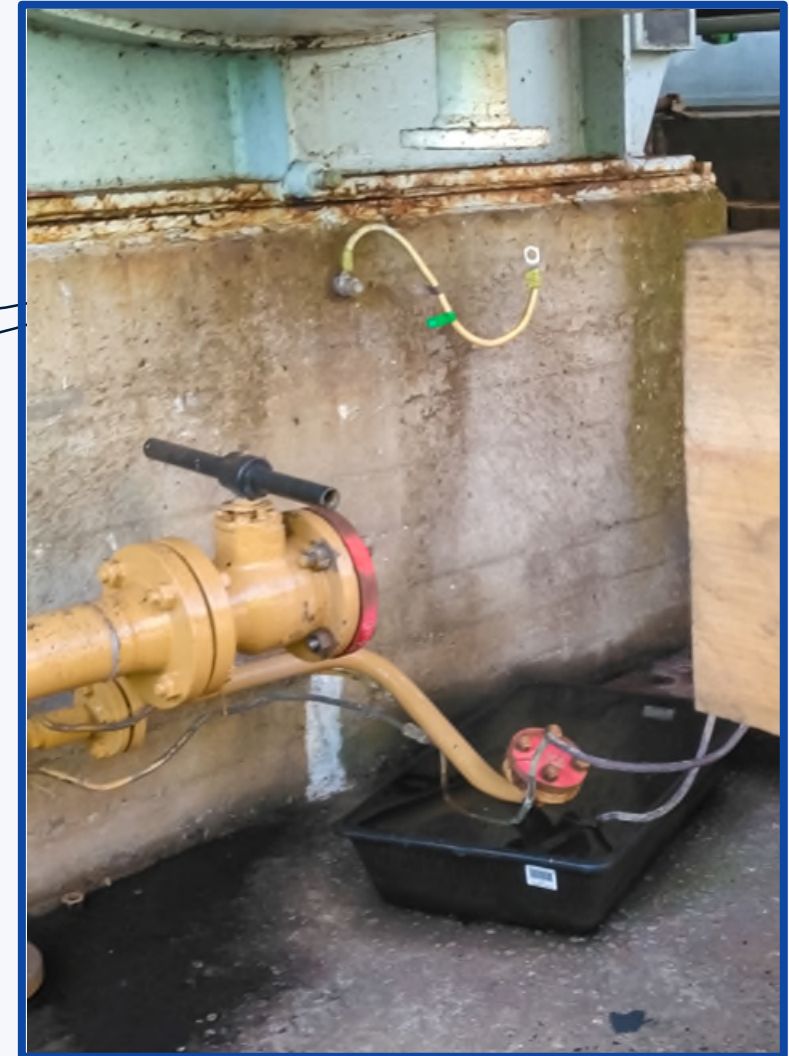
Setup: HDPE drum under bottom nozzle V2008

- **In our case:**
 - **Diameter 2.8 meter, water flow 200 l/min), but pressure range from 200-800 bar(g)**
 - **Residual IPE floats on water**
 - **Earthing**
 - **Vessel: 2 loose earthing cables, assumed to be preparation for theft**
 - **Suction hose/vacuum truck: not earthed**

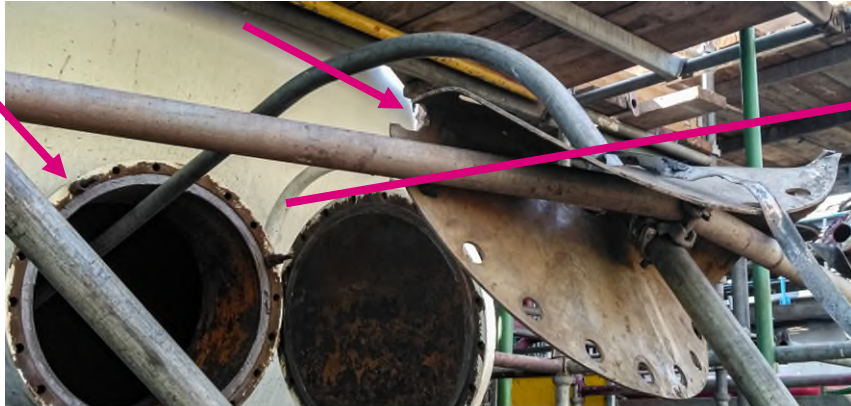
- Vibration between Aluminium Butter plate and corroded bolts -> **Thermite reaction**, which has generated heat -> no proof found
