Pyrophoric hazards

Smoldering fire in vacuum column during shutdown Virginie HOUILLIEZ

May 2017– Germany –Vacuum column in a refinery

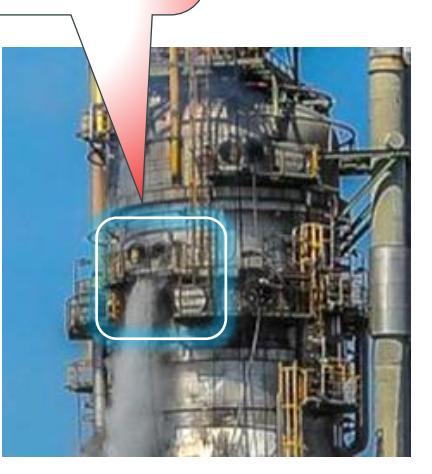
Manhole n° 11 open

- 11:41 ----- Evacuation of people inside the column (below the concerned beds) ----- Water injection into column via recycle line on top of the column
- 11:44 ----- Emergency Response Plan activated and evacuation of all refinery units
- 11:58 ----- External column cooling (sprinkler system and fire brigade)
- 12:37 ----- Steam from the bottom commissioned (up to 17t/h), after deblinding
- 12:45 ----- Lower manholes closed (N°1-9) by fire brigade
- 12:55 ----- Rescue of 3 Unit contractors trapped outside of the column at top level
- 14:38 ----- All temperature indications below 500°C (end of measuring range)
- 14:55 ----- Emergency Response Plan deactivated
 - ----- Column left under water flushing from top, closing of manhole N°11

- 1- Opening of all manholes by contractors (not in line with work peremit)
- 2- Degraded mitigation measure efficiency (man hole 11 open \rightarrow injected water did not reach the bottom of the column)
- 3- Kinetics of accident did not allow to activate mitigation measures in place (fire hoses ready to use at each manhole)
- 4- Lack of supervision

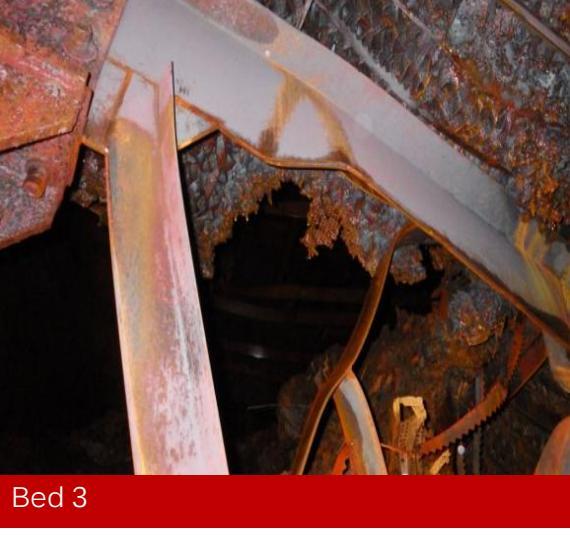
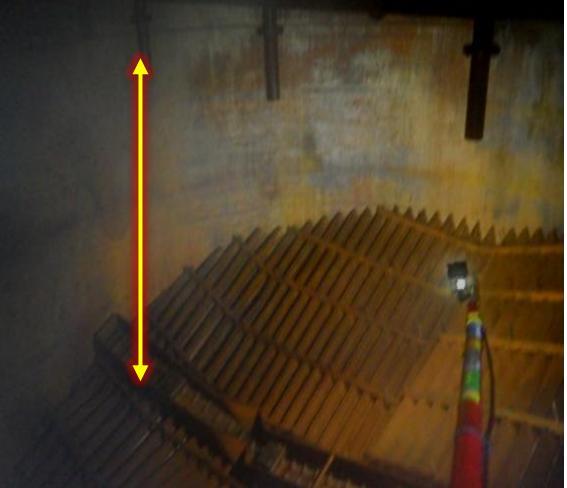
Column internals severely damaged; shell can be reused showing limited damage 6 0 Bed 1 0 OK Bed 2 Bed collapsed 6 Beams slightly deformed Bed 3 8 Bed destroyed Bed 3 Beams bent out of shape • 53 m Chimney tray broken down 0 Bed 4 B Beams partially damaged 6 Packing partially ok 6 Bed 5 Packing partially damaged Beams OK 0 0 Bed 6 Bed 6 intact (but anyway SD scope) ð
