Human factors in incident investigations

- Laurence Thring
- Huntsman Holland bv
- Process Safety & Sustainability Manager

Hydrogen Jet Fire

Cut in finger associate QC lab

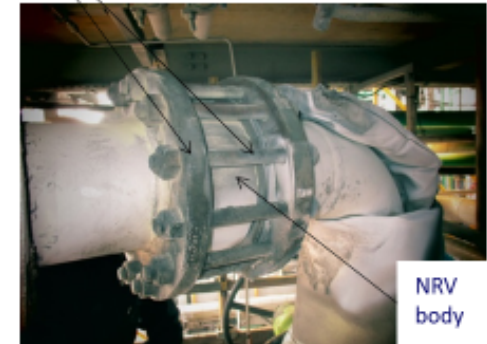
Following maintenance to a 6" non return valve (NRV), hydrogen leaked on restart which self-ignited and damaged cabling. It burned for approximately 10 minutes before being extinguished, from the Control Room, by isolation of the plant hydrogen supply.

- The bolted NRV installation was not leak tight (gasket was poorly centralised).
- A defensive layer to leak test disturbed joints on H2 service, before commissioning, was not carried out.

Gaskets fit here

Under close supervision, the original 1979 installation could not be re-assembled reliably and has therefore been redesigned. Other human and environmental factors contributed to the defective assembly and a policy for mechanical fitters to report difficulties to an engineer has been reinvigorated.

The operating procedures did not make leak testing requirements sufficiently clear and have now been updated to include 100% nitrogen leak testing of all disturbed joints on hydrogen duty.

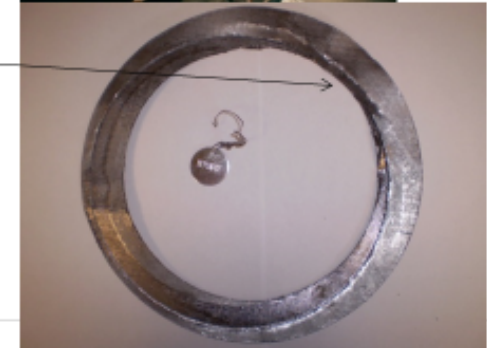
Gasket not sufficiently compressed in this location

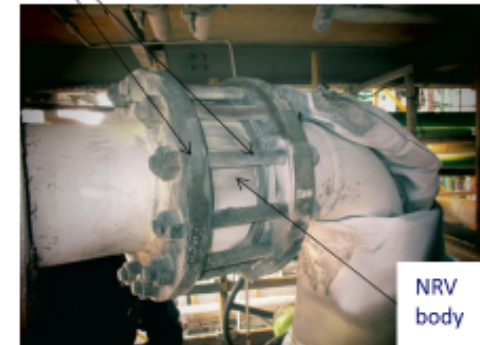
Gaskets fit here

Very difficult assembly process
Unclear escalation procedure
Unclear Leak test procedure

NRV gasket leaked

Under close supervision, the original 1979 installation could not be re-assembled reliably and has therefore been redesigned. Other human and environmental factors contributed to the defective assembly and a policy for mechanical fitters to report difficulties to an engineer has been reinvigorated.

The operating procedures did not make leak testing requirements sufficiently clear and have now been updated to include 100% nitrogen leak testing of all disturbed joints on hydrogen duty.

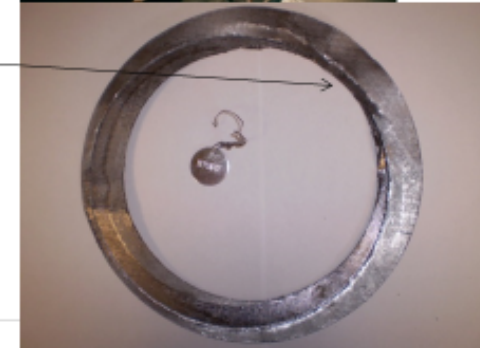
Gasket not sufficiently compressed in this location

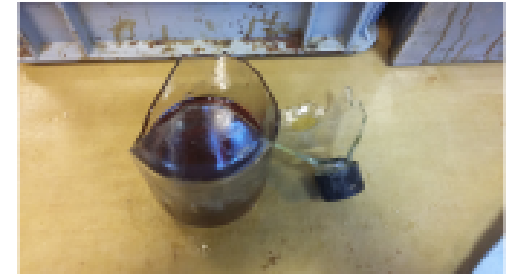
On Monday morning, December 30, an associate in the QC lab tried to open a jar containing MDI prepolymer. When pouring the Variants out of the jar, it can drip onto the glass threads around the mouth. As a result the cap can stick to the threads so that it cannot be opened by hand. The associate tried to open the jar with a wrench. He held the jar tightly with his right hand and used the wrench as extra leverage on the cap. The jar broke and the glass cut his right finger. Associate went directly to the Medical Center. The +/- 8 cm long cut was treated with 12 stitches. The associate wore the standard blue gloves prescribed for work in the QC lab.

- Best practice for this activity will be agreed across the PU Sites (inc Everberg), led from Rotterdam.
- Safety Cross has been implemented in the QC Lab and further Risk Tolerance workshops planned for 2020.
- Manning levels for the Foam lab on Mondays has been changed on a trial basis. The effect of this change will be reviewed in 3 months.

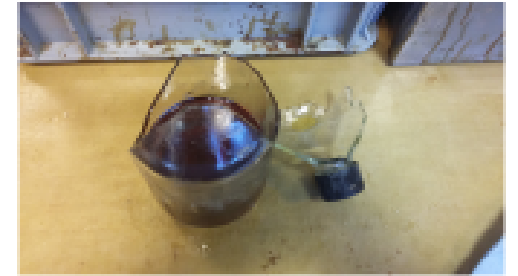
On Monday morning, December 30, an associate in the QC lab tried to open a jar containing MDI prepolymer. When pouring the Variants out of the jar, it can drip onto the glass threads around the mouth. As a result the cap can stick to the threads so that it cannot be opened by hand. The associate tried to open the jar with a wrench. He held the jar tightly with his right hand and used the wrench as extra leverage on the cap. The jar broke and the glass cut his right finger. Associate went directly to the Medical Center. The +/- 8 cm long cut was treated with 12 stitches. The associate wore the standard blue gloves prescribed for work in the QC lab.

- Perceived work time pressure
- Colleague did not say 'stop'
- Other sites avoided the scenario
- LMRA not consciously done

Incorrect tool used to open bottle

- Best practice for this activity will be agreed across the PU Sites (inc Everberg), led from Rotterdam.
- Safety Cross has been implemented in the QC Lab and further Risk Tolerance workshops planned for 2020.
- Manning levels for the Foam lab on Mondays has been changed on a trial basis. The effect of this change will be reviewed in 3 months.
