Congres **Process Safety** May 14, 2025 - Dordrecht

Bhopal 40 Years on

What Have We Learned?

Bhopal, 40 years on

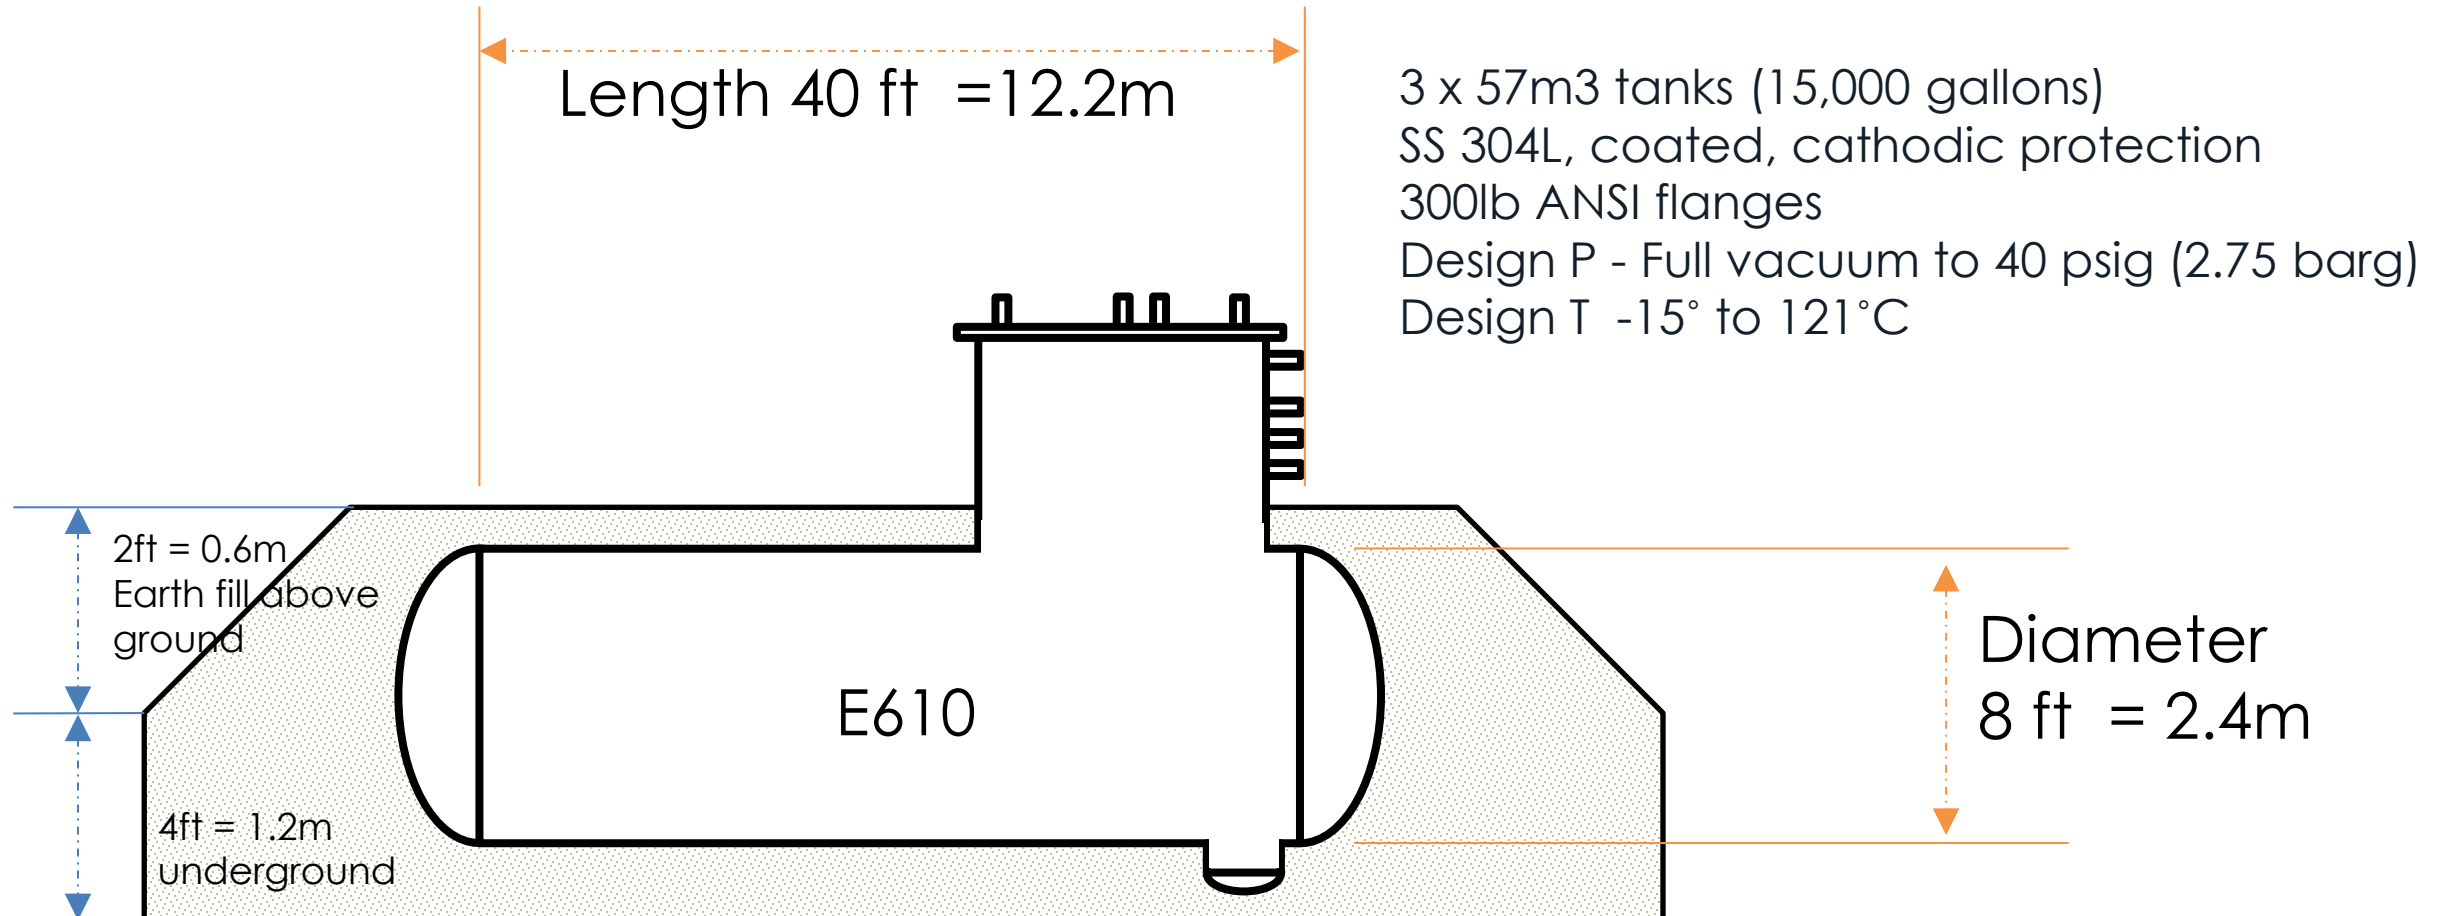
3 x MIC Storage Tanks

Methyl Isocyanate (MIC) Storage Tanks

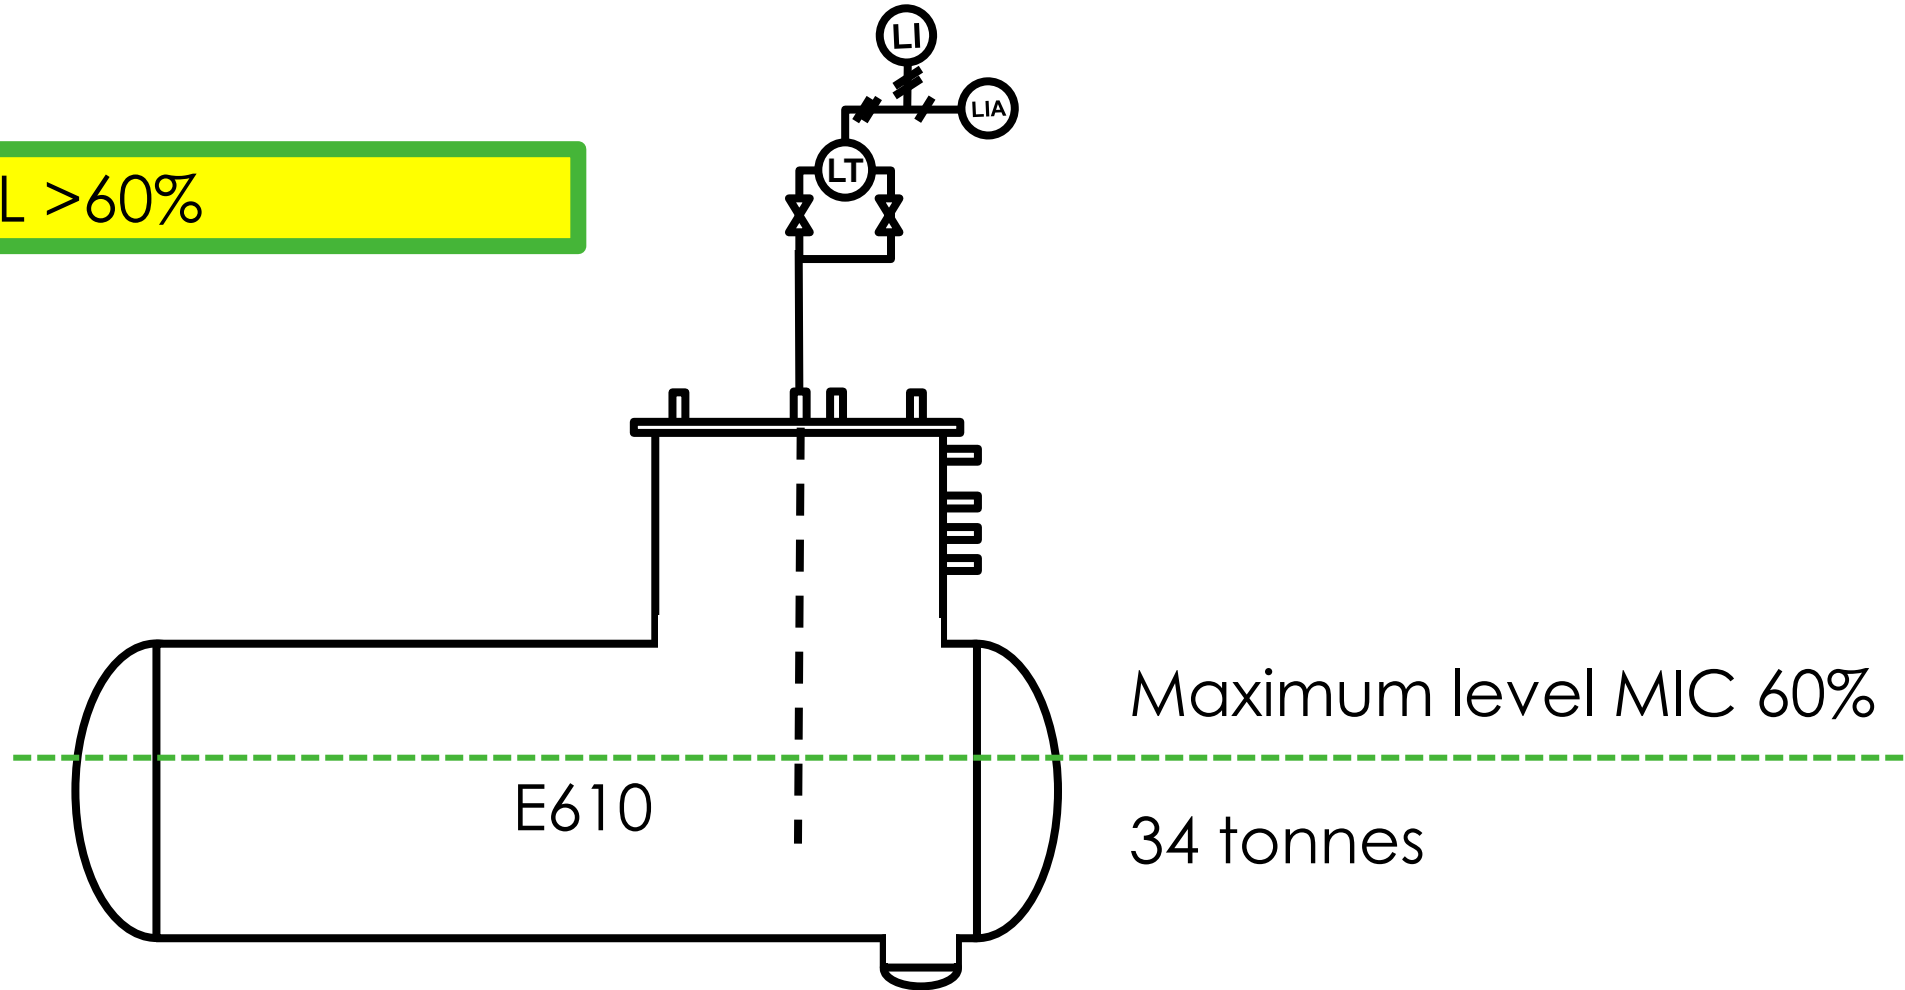
E610 – Level Indication

$20\% < L < 60\%$

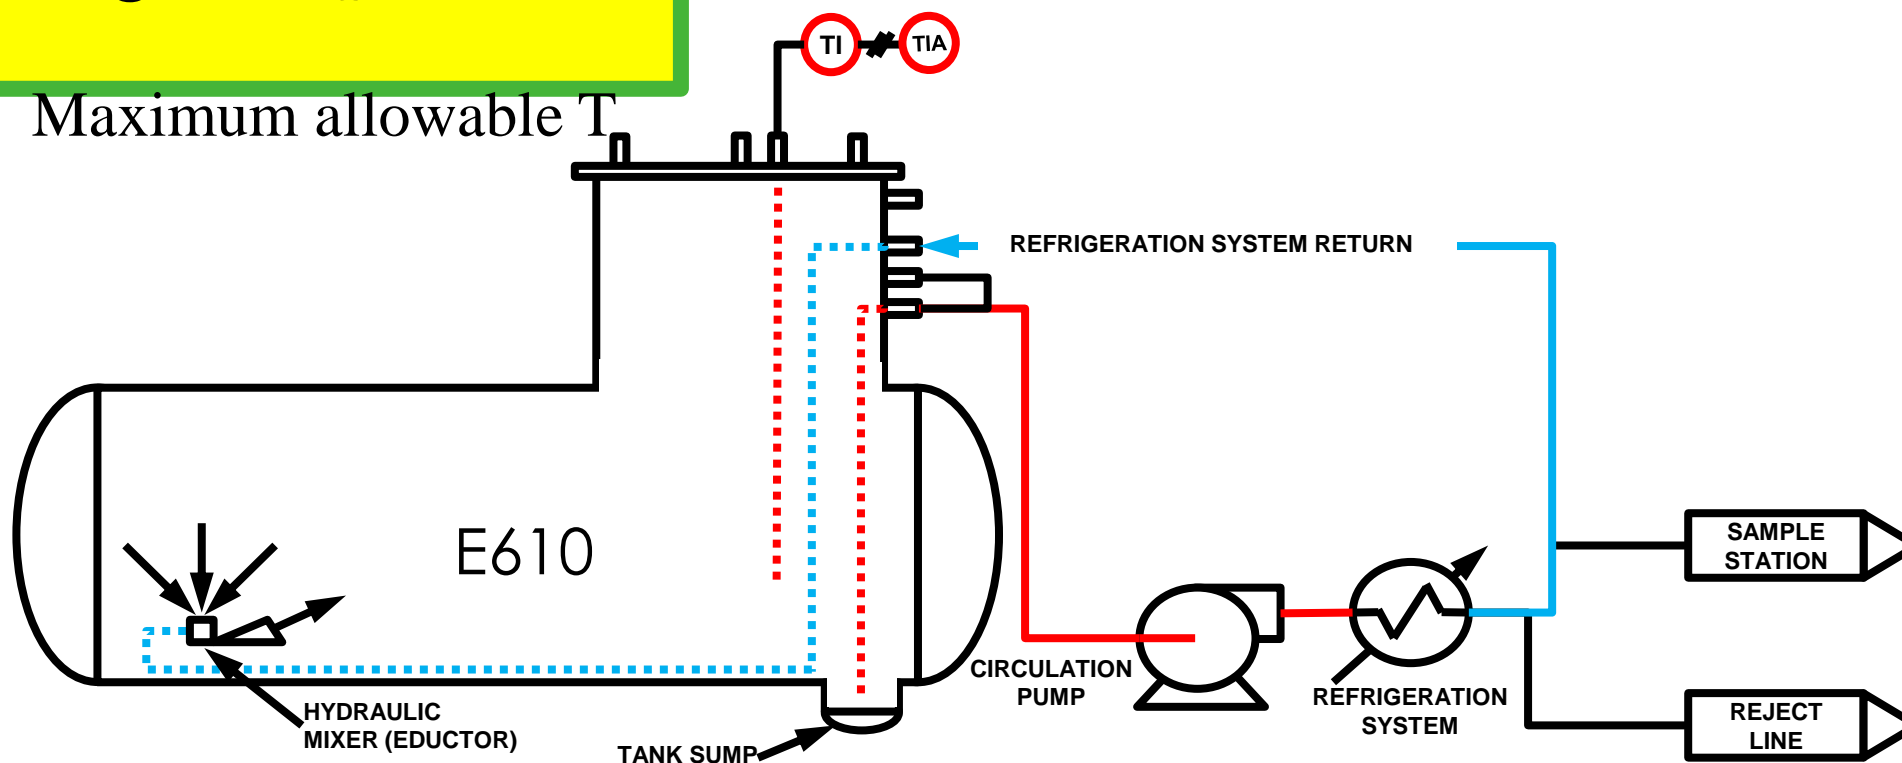
E610 – Temperature Control

$T = 0^{\circ}\text{C}$ Design Storage T
 $T > 11^{\circ}\text{C}$ High Temperature Alarm

$T = 15^{\circ}\text{C}$ Maximum allowable T

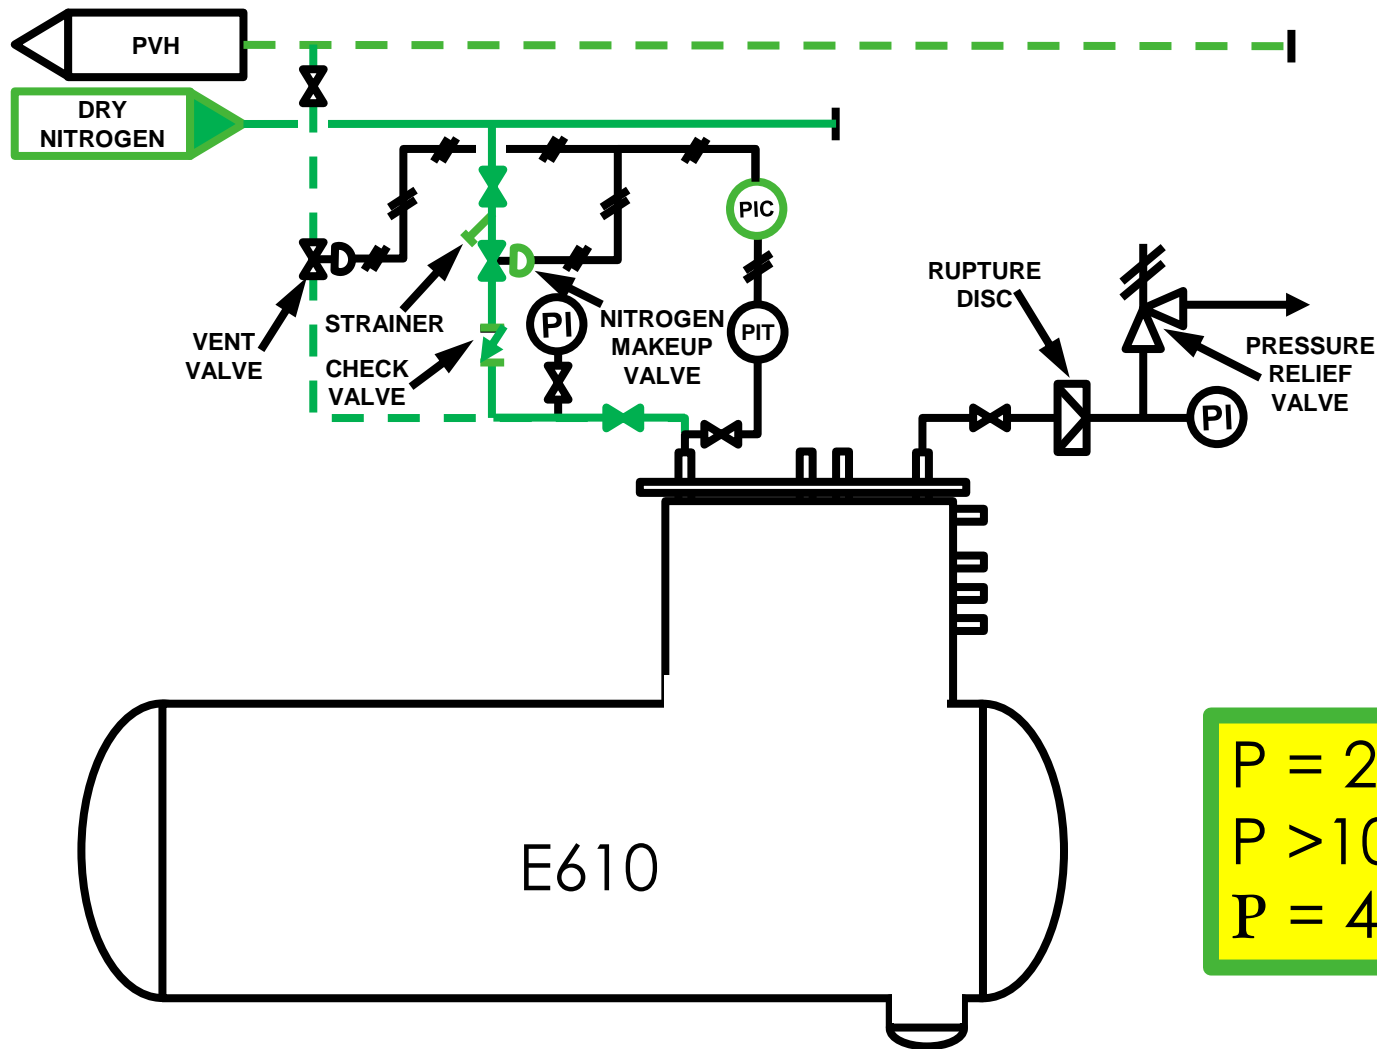
E610 – Pressure Control

P = 2 psig Design Storage P
P > 10 psig Max P (USA)
P = 40 psig Relief BD+PRV

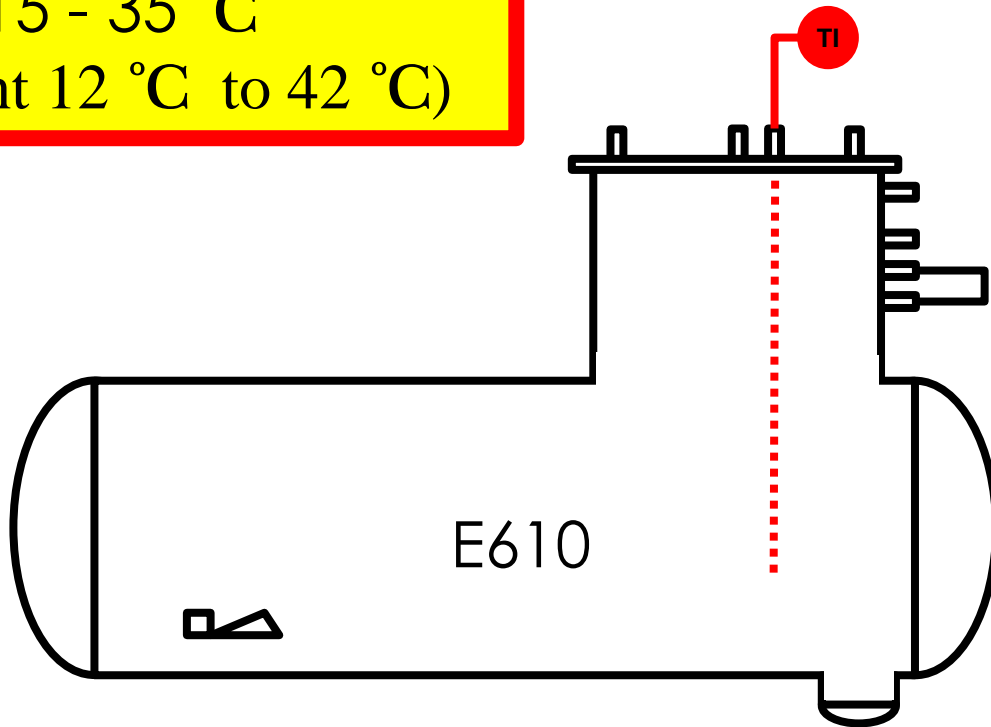
E610 – Temperature 1984

Actual temperature
15 - 35 °C
(Ambient 12 °C to 42 °C)

No refrigeration

Permanent T alarm

No Circulation

No Sampling

No Reject route

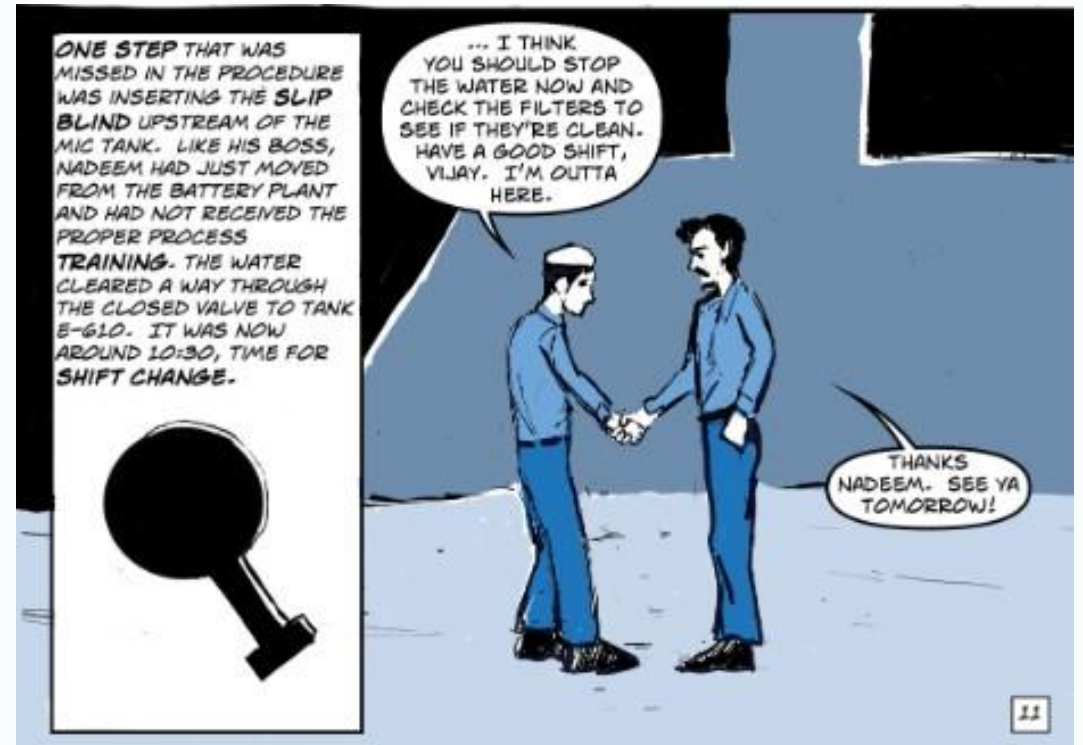
During the cleaning of choked filters with water in the Relief Valve Vent Header, such water could have entered the non-pressurised tank and may have carried some metallic contaminants from the carbon steel portions of the header pipelines

Water used to wash filter No Isolating blank installed

Water-washing of
lines in the filter
area could not
possibly have been
the cause of water
entry into Tank 610

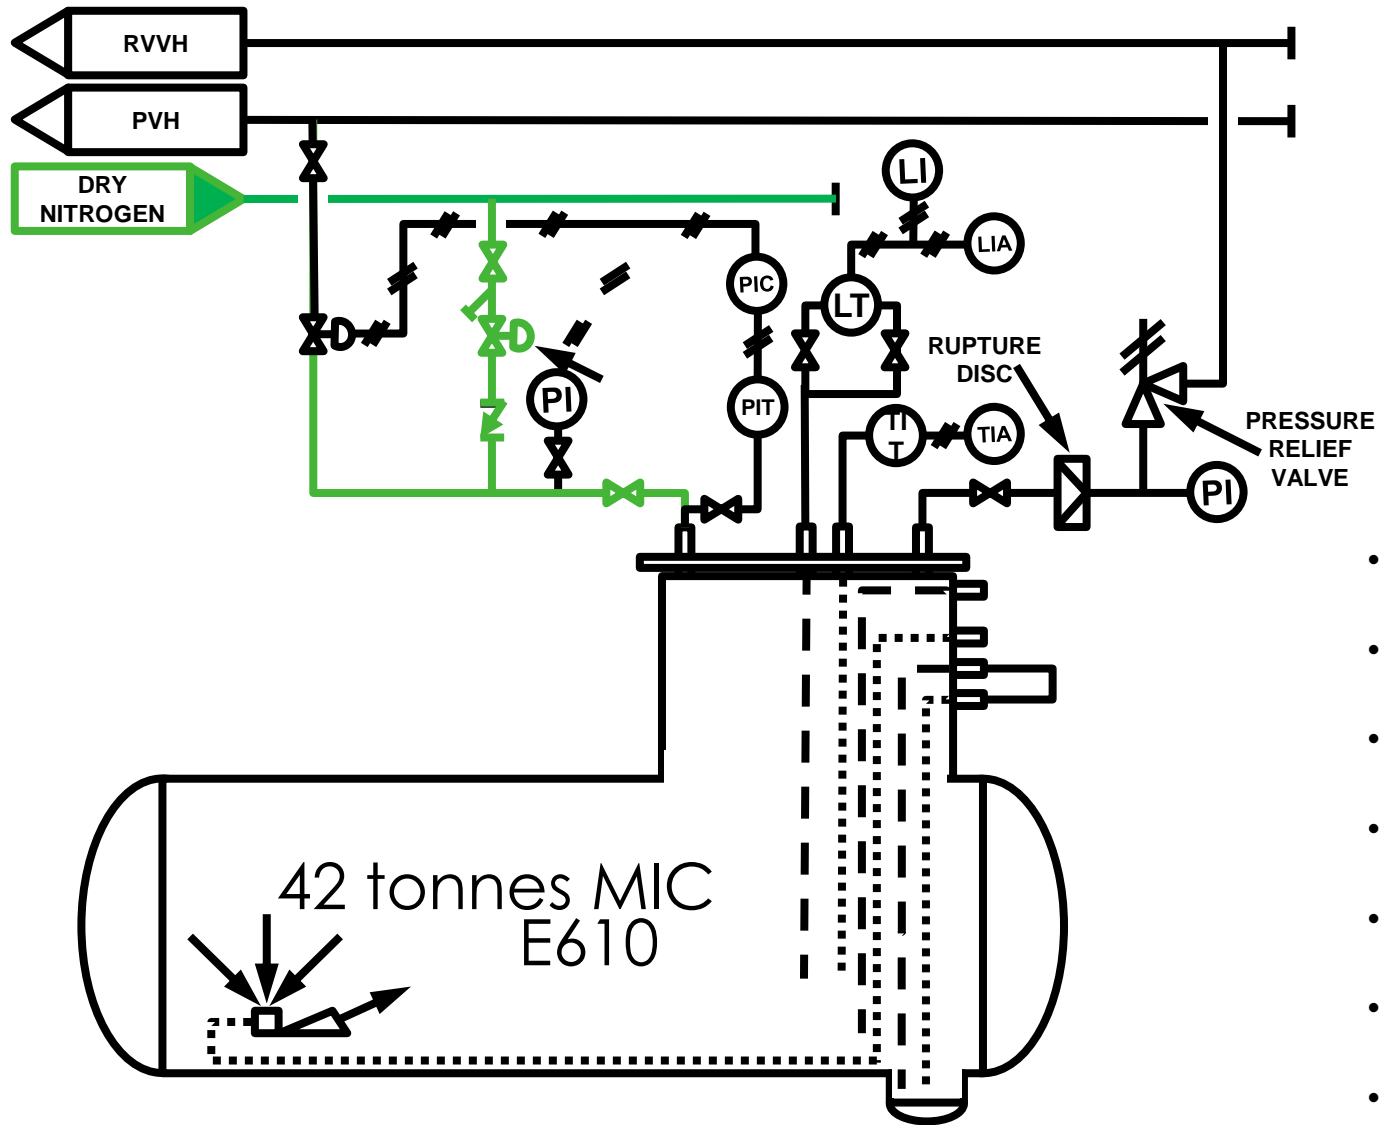
- NO TRANSFER PUMP
- NO CIRCULATION PUMP
- NO INTERNAL TANK MIXING
- NO SAMPLING SYSTEM
- NO REJECT ROUTE
- NO REFRIGERATION SYSTEM
- NO MAINTENANCE SUPPORT
- 27 DAYS TO CLOSURE

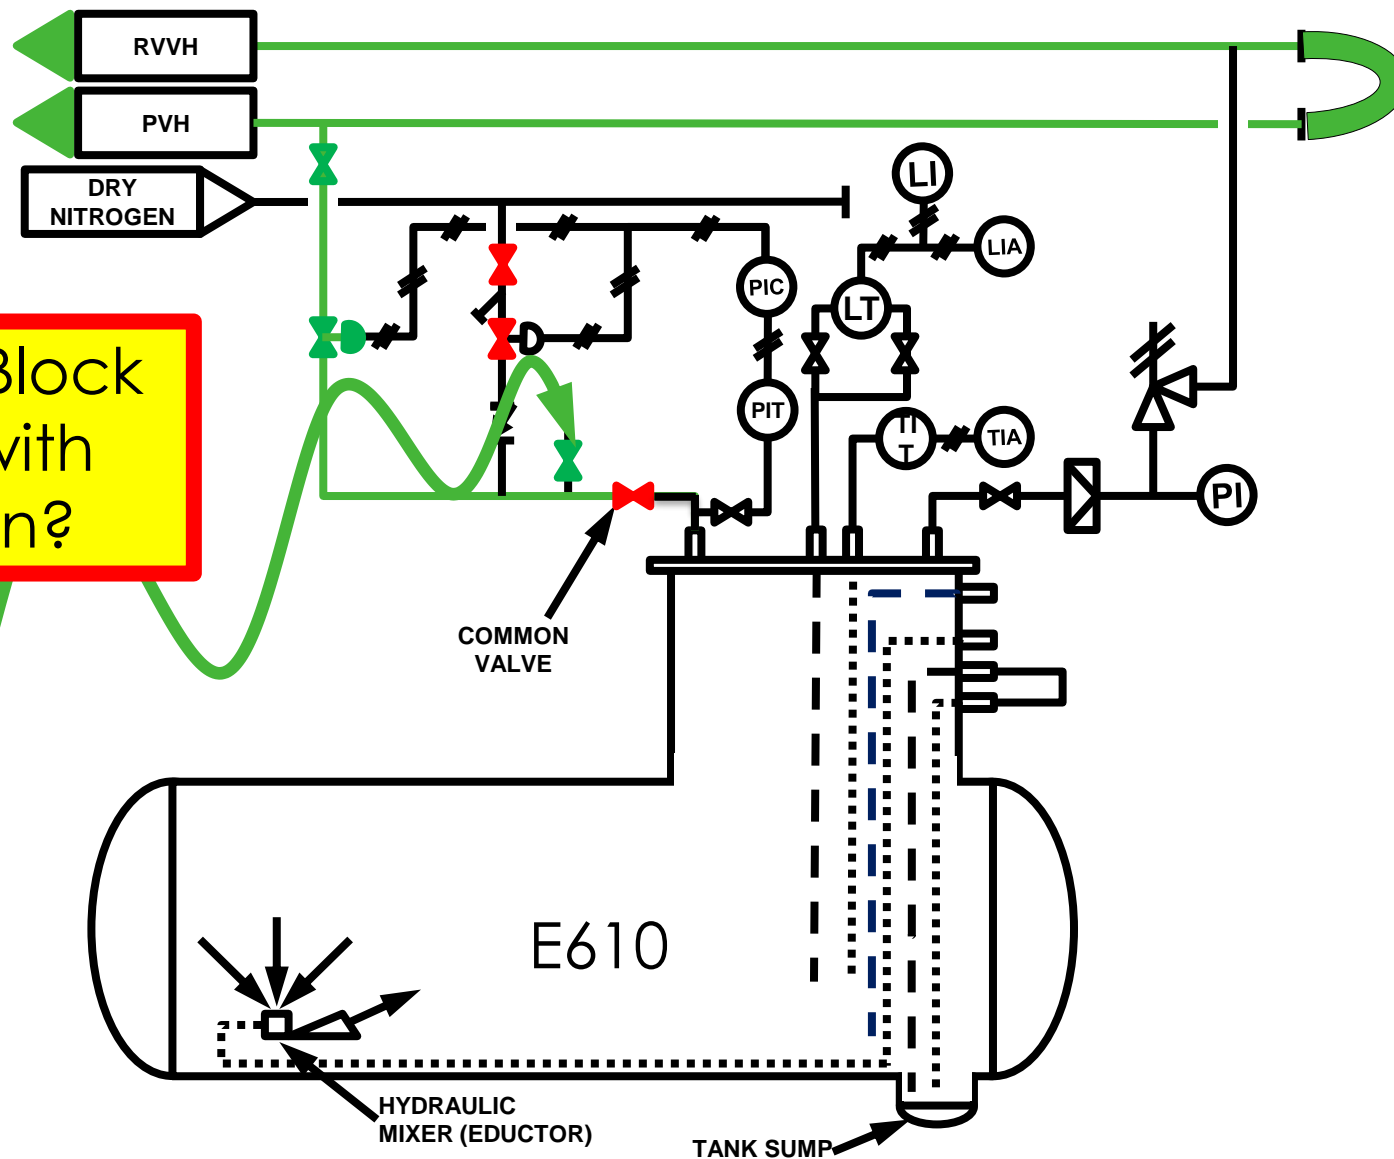
Process Vent Header
connected to
Relief Valve Vent Header

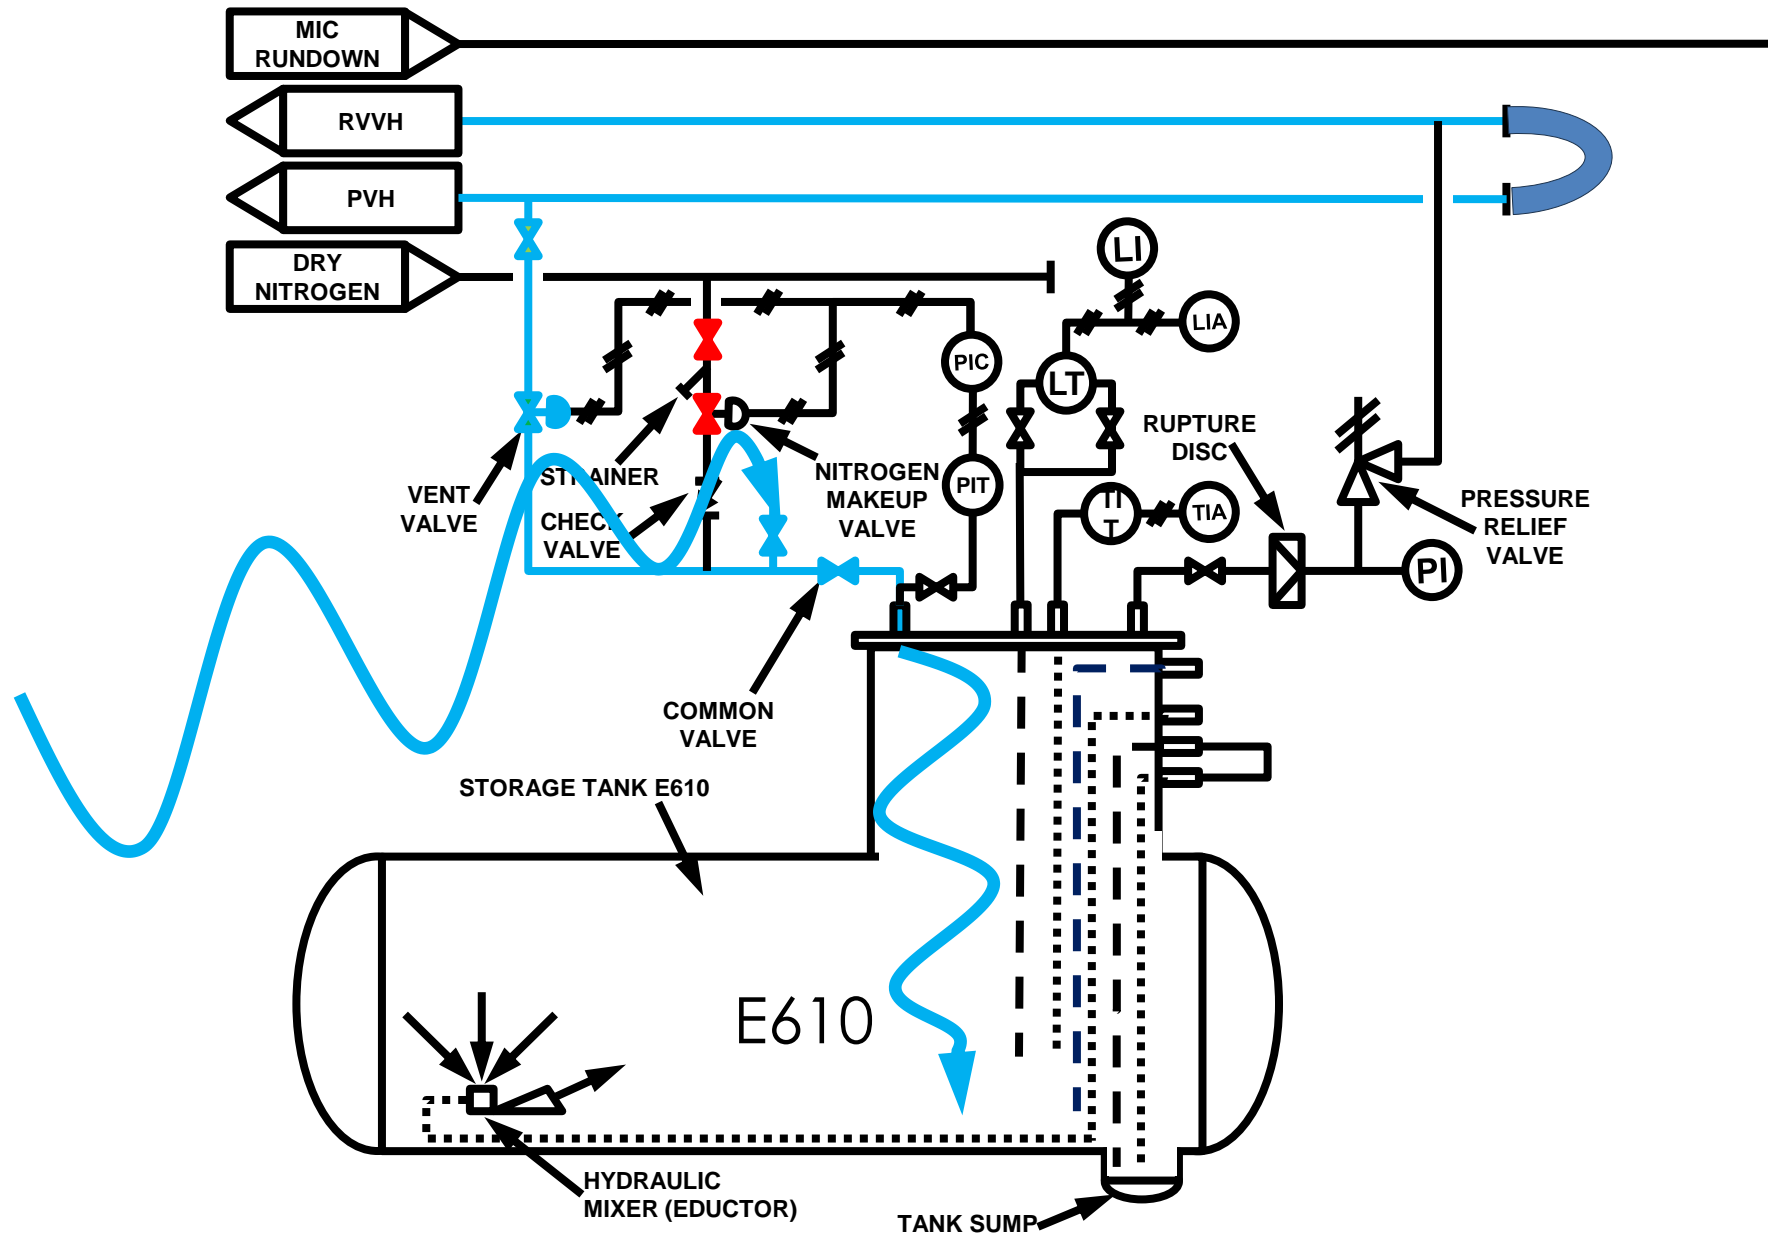
I
Process Vent Header
connected to
Relief Valve Vent Header

Relies on single isolation
COMMON VALVE
