# Process Safety Congress 14<sup>th</sup> May 2025

## Preventing disaster - How captive key locks could have averted two industrial accidents

G-G-BD-E-PUB-25-05-001-01-EN

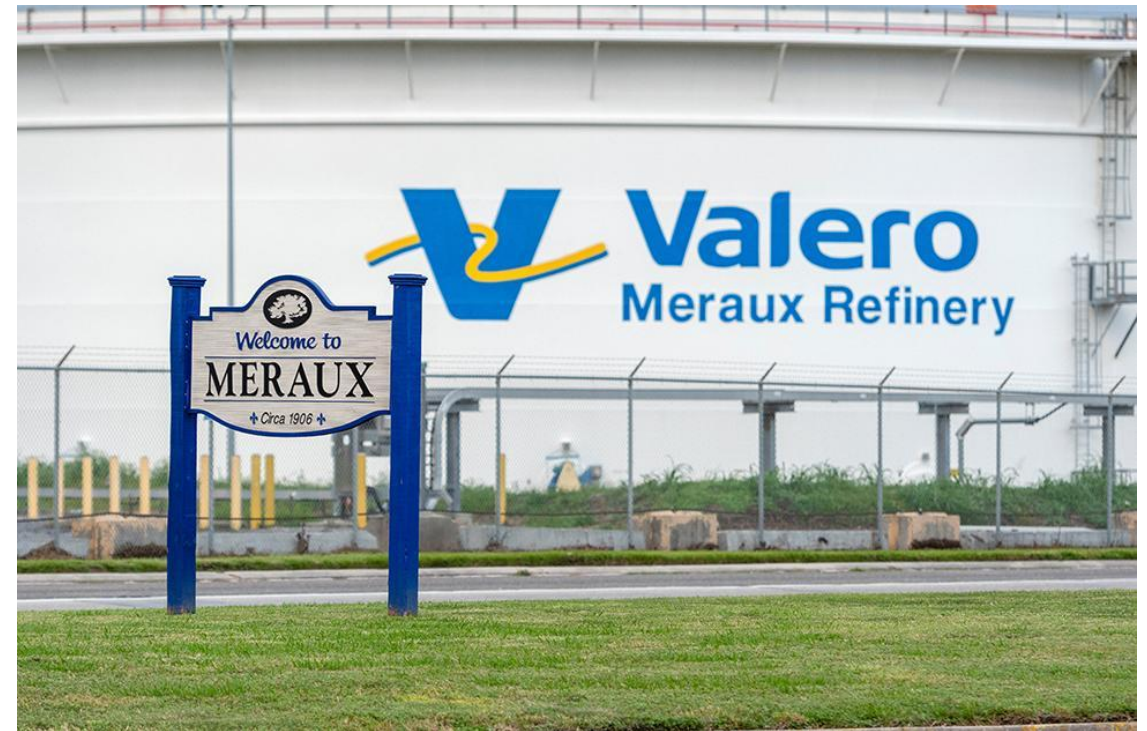
Picture by Valero Meraux Refinery

- After a heavy rainstorm, the flow of the Hydrocracker unit's flare began increasing
- An emergency pressure-relief had a malfunction and remained open
- A "reseating" was ordered and approved
- Safety concerns to access the 6" inlet valve
- Decision was made to close the 20" outlet valve

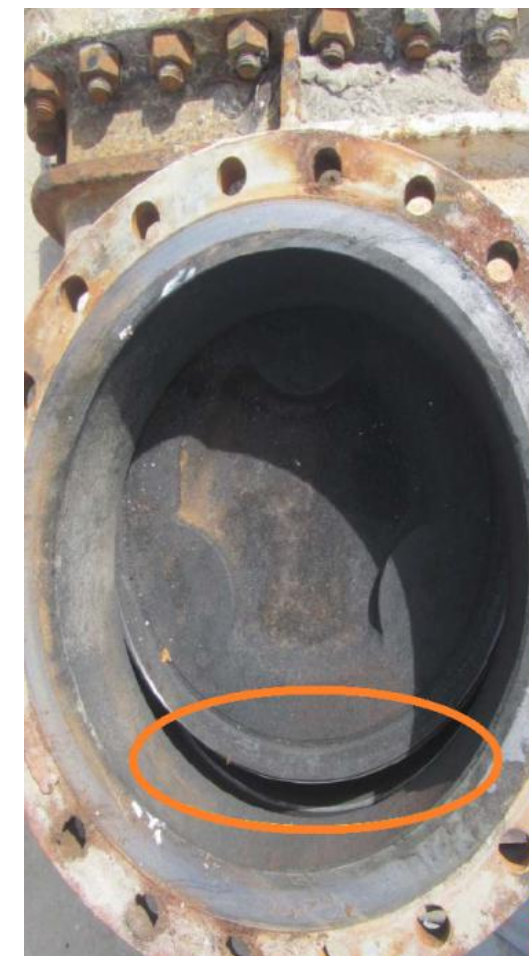
Picture from CSB Incident report Volume 1 Page 5

- The 6" inlet valves are designed for 2470 psi
- After the outlet valve 20" 275 psi was closed by about 90% the valve failed
- Releasing a high-pressure mixture of hydrogen and hydrocarbon vapor into the surrounding air
- The flammable gas formed a vapor cloud, ignited and resulted in the explosion and fire.

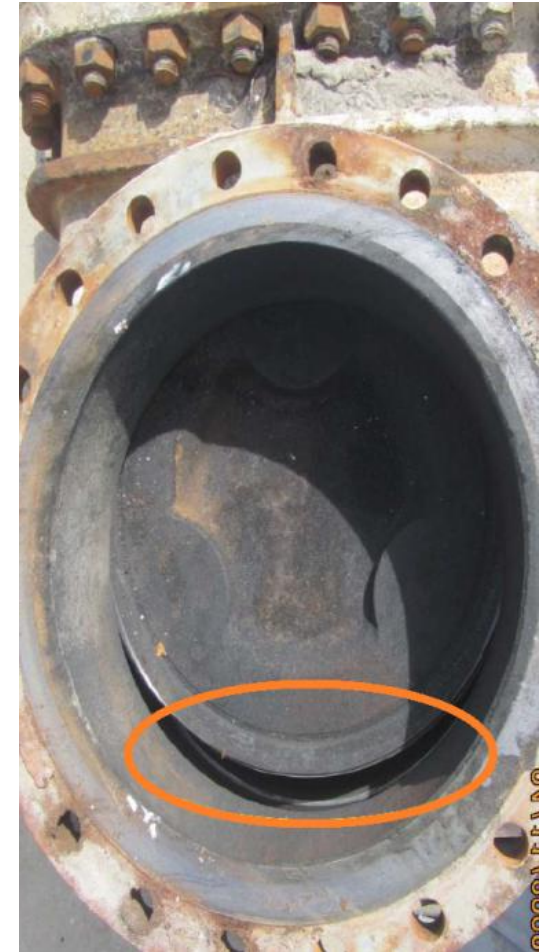
- Implementing a captive key lock solution
- Including the inlet **AND** outlet valves into the solution
- Guarantee a continues over pressure protection of the equipment
- Guarantee overpressure protection of the outlet line and valve

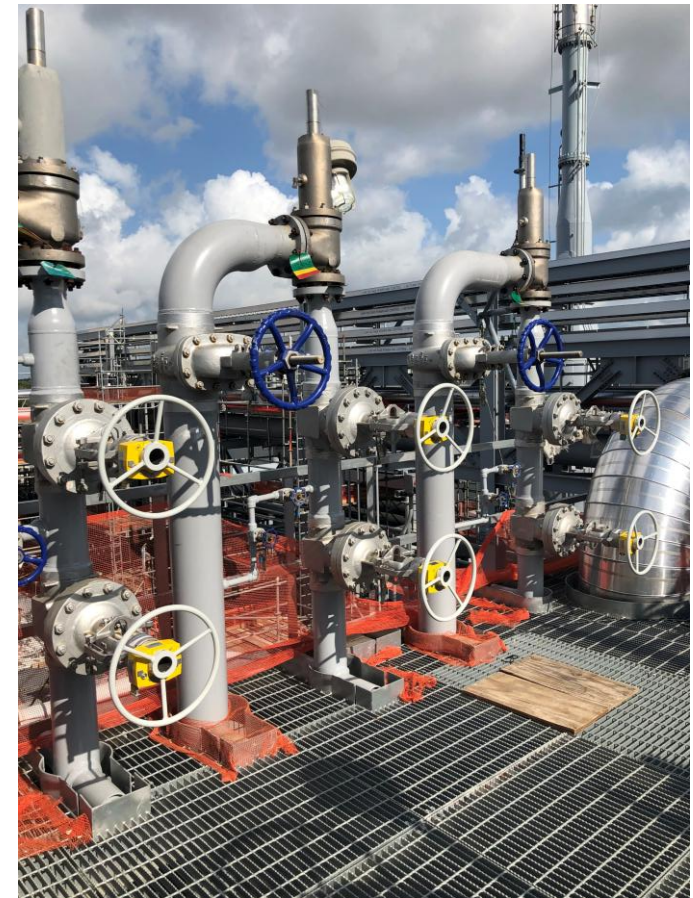
- Safe operation of a redundant PSV system (guaranteed protection of the equipment)
- Protection of the outlet valves against overpressure
- Clear indication of the isolated PSV by the end key
- Easy implementation of pilot valves in case of pilot operated PSV
- Optional the cascading of redundant PSV 's can be realized to prevent chattering

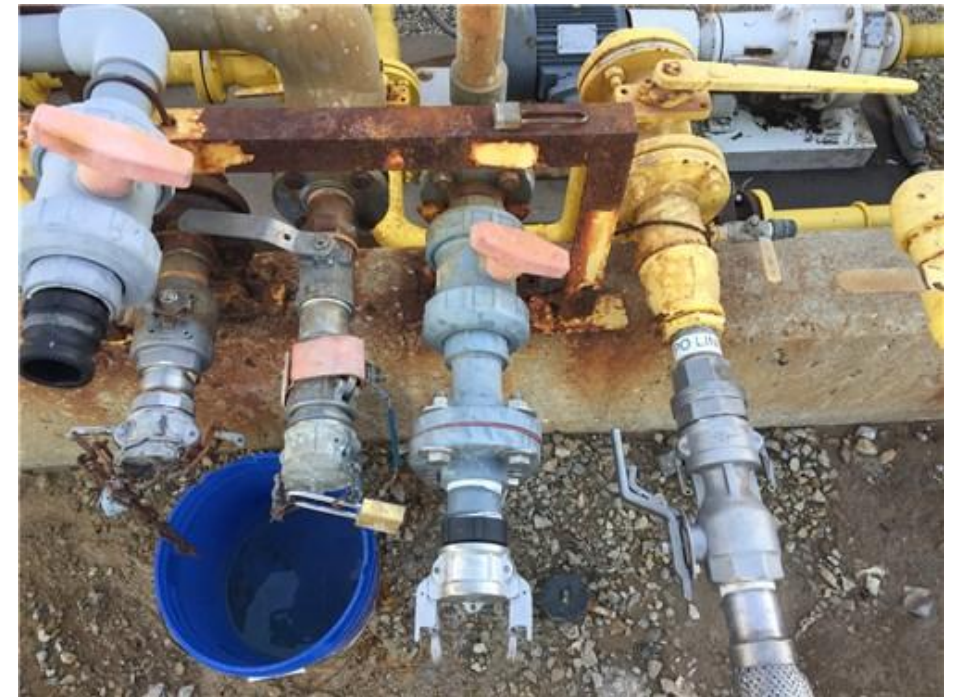
- Operator from the night shift accepted the delivery of 30% Sulfuric Acid
- Operator escorted the driver to the chemical unloading area.
- Operator unlocked the gate in front of the transfer equipment and removed the lock on the cam lever dust cap for the sulfuric acid fill line.
- Operator reports that he pointed out the location of the sulfuric acid fill line.
- Driver reports that the operator did not point out the fill line.

Chemical unloading operations at the time of the incident (Source: CSB / MGPI)

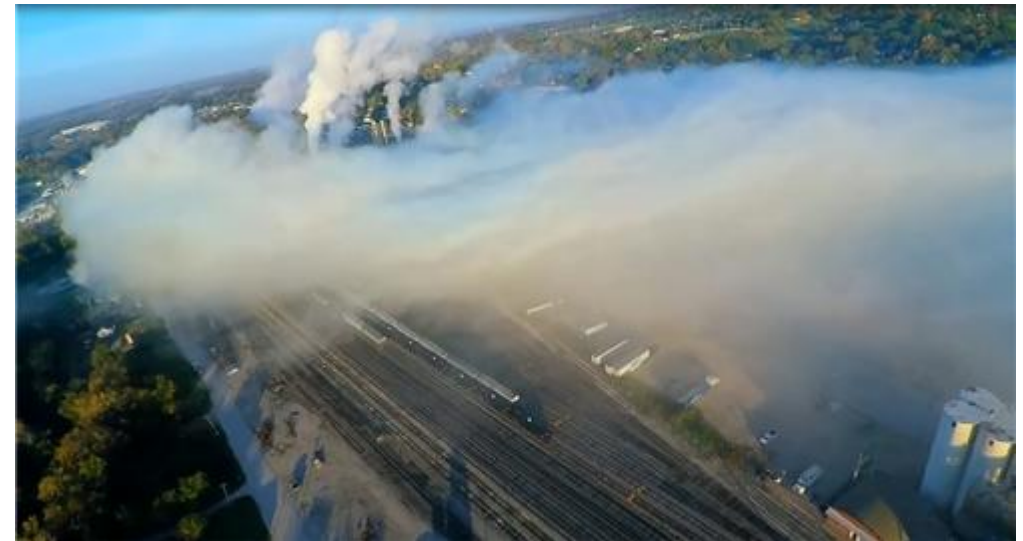
- The Sodium Hypochlorite fill line was unsecured and therefore accessible for the driver.
- 4.000 gallons (15 m<sup>3</sup>) of Sulfuric Acid got mixed with 5.850 gallons (22 m<sup>3</sup>) of sodium.
- The chemical reaction produced maximum theoretical 3.490 pounds (1,6 tons) of chlorine gas and other gases.
- The gas were released through a 3" atmospheric vent and an 18" lid on the roof of the bulk tank.

Released Chlorine Cloud (Source: CSB)

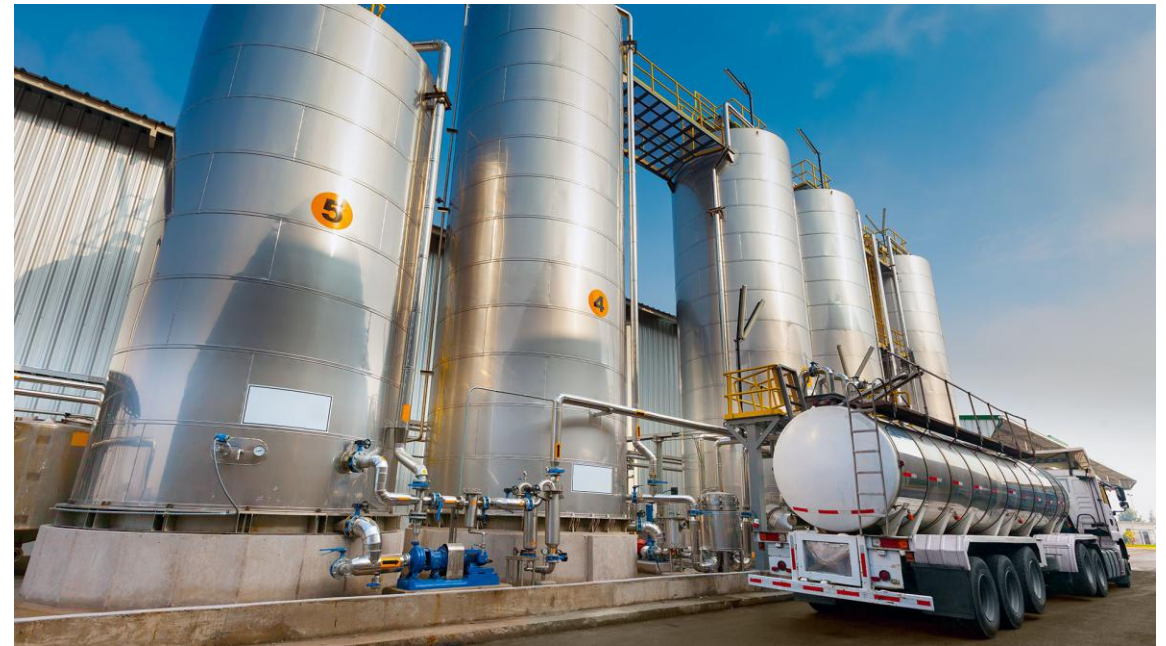
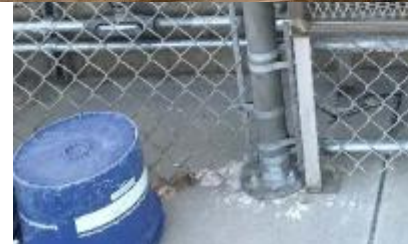
- Implementation of incompatible line sizes.
- Usage of incompatible connection shapes
- Proper fill line marking.
- Separation of unloading connections with secure cages around connection points.
- Sofis SiLoC solution.

Separation of unloading connections (Source: CSB)

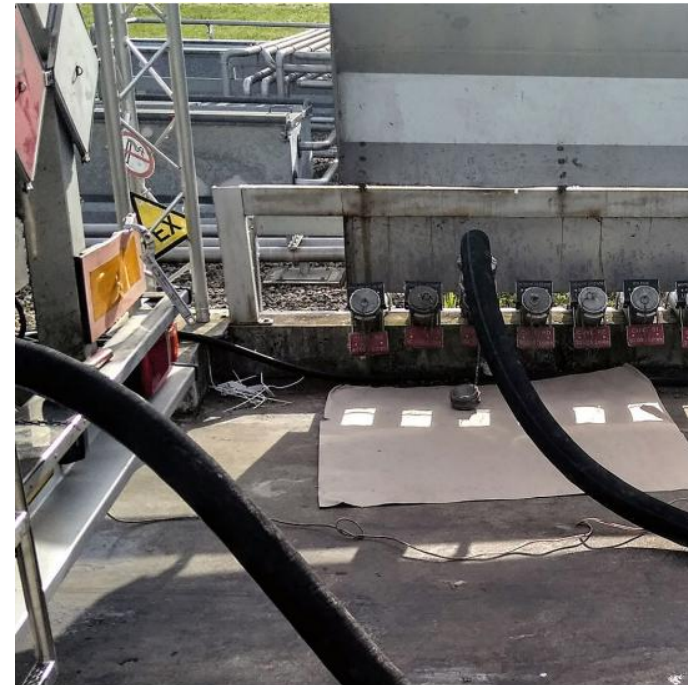
- Elimination human errors during fill line selection process
- Unique key per silo
- Grouping of silos optional
- Interlocking of silos against each other during loading
- Connection to SCADA System possible
- Connection to DCS for interacting with other equipment
