Protection from Hazards – Human behaviour

DuPont Belle incident

The failure- chronology of events

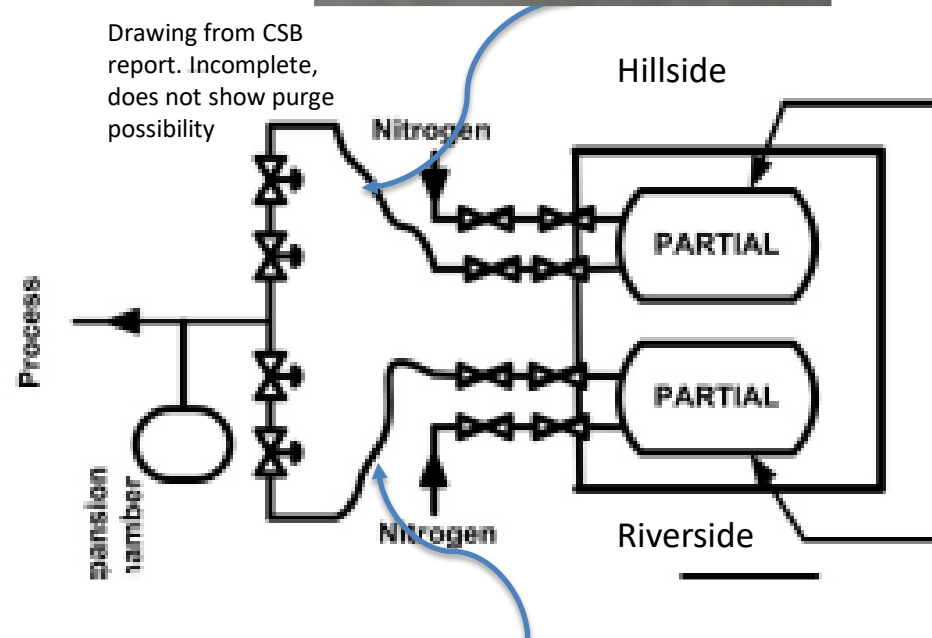
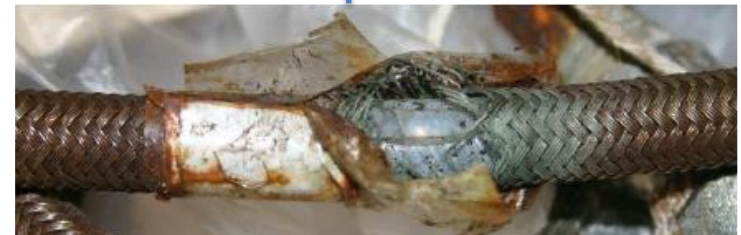
Drawing from CSB report. Incomplete, does not show purge possibility

70 Psig N₂ purge. Drawing from CSB report is incomplete, does not show purge possibility.

0.25-inch diameter by 48-inch long PTFE-inner tube, 304 stainless steel overbraid hoses

PTFE is known to be permeable to phosgene, creating stress corrosion cracking under the label
