Explosion

During high pressure water cleaning

May 5-6 2022

Westlake

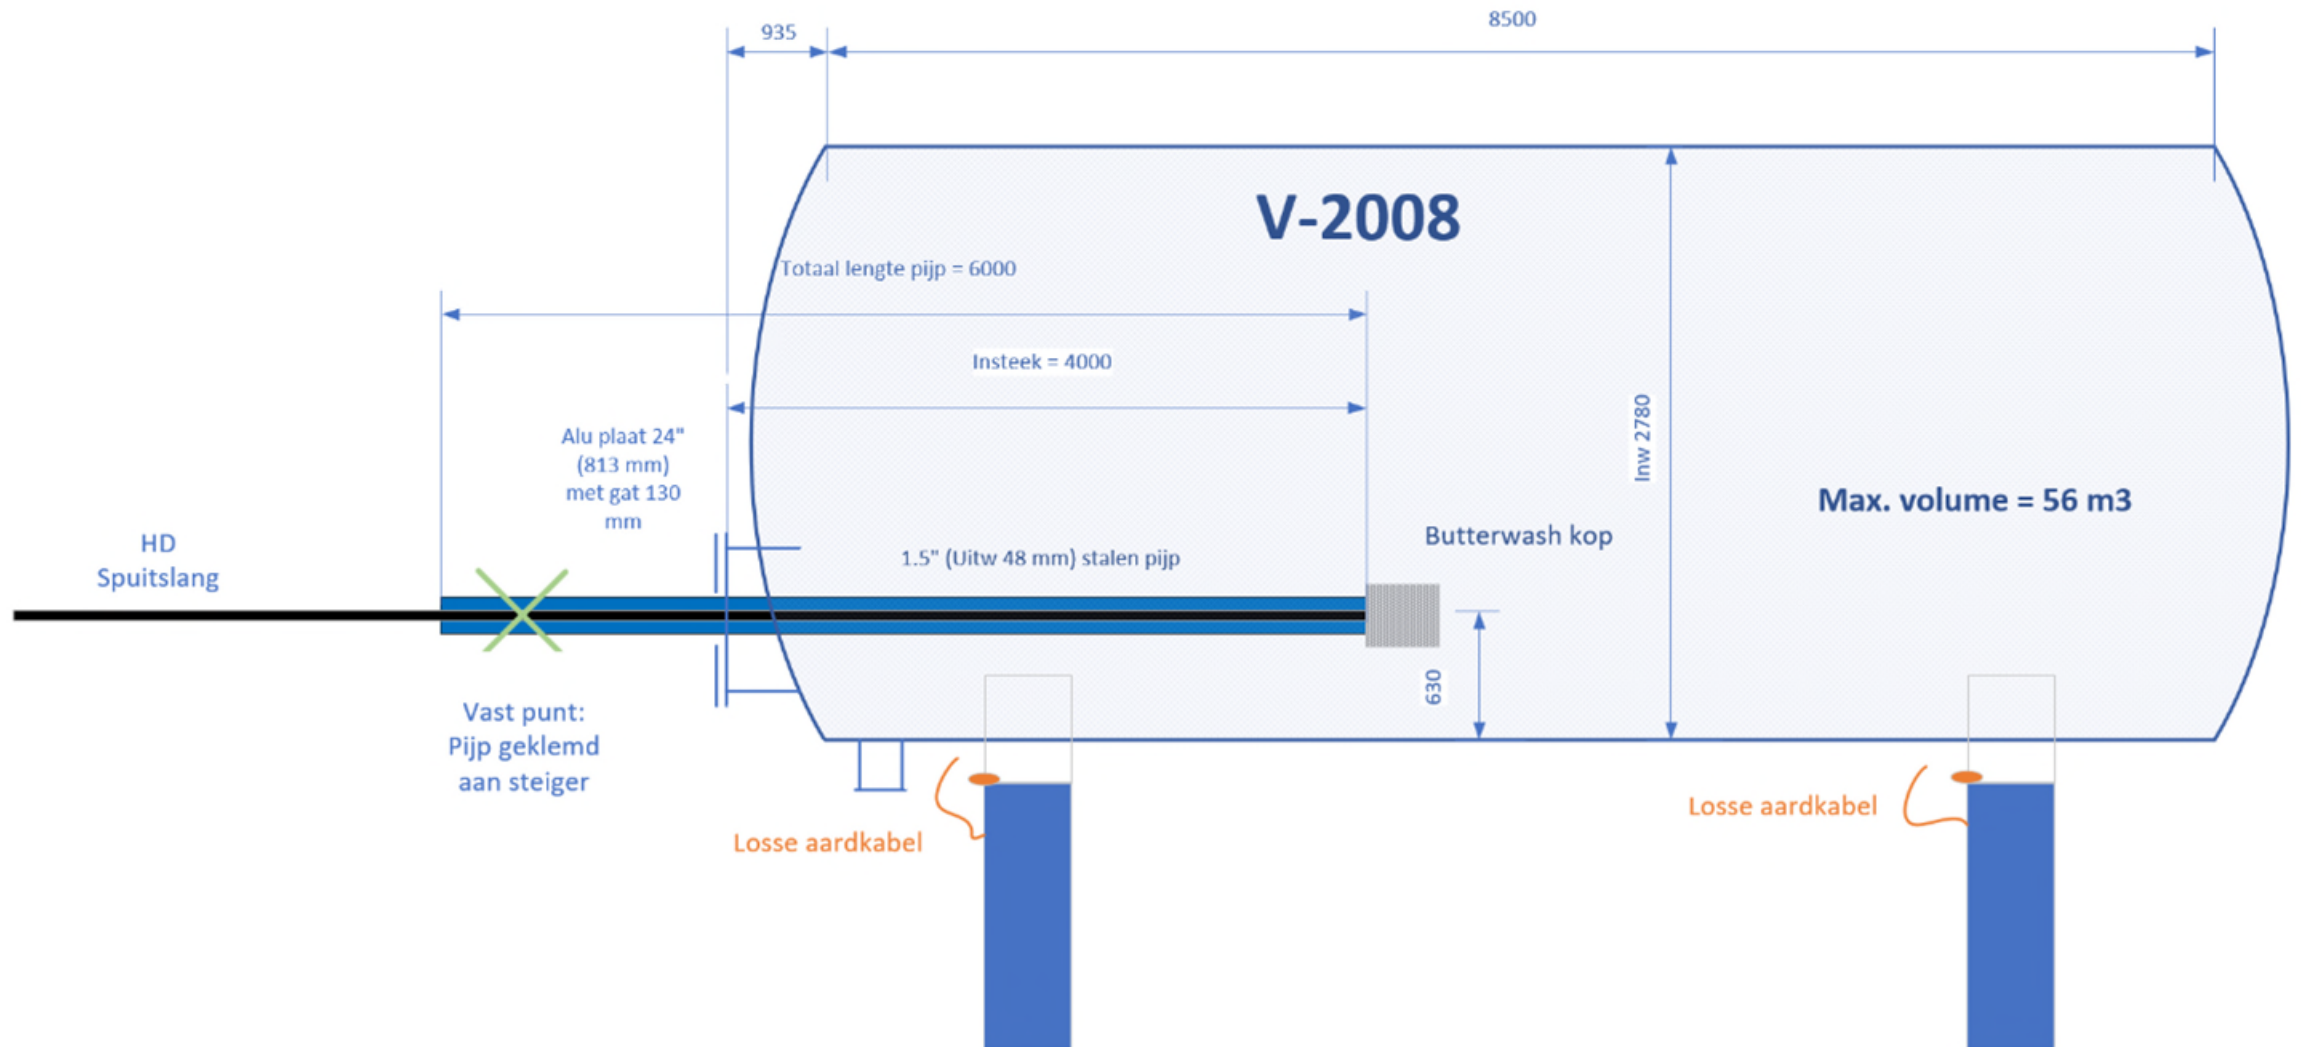
Cleaning setup

- Manhole blind flange opened (Vessel bottom nozzle (3") was already open)
- High pressure water truck and Vacuum truck located at work spot, including facilities
- Butterwash unit installed
- Drain drums put under vessel
- Suction/cleaning hose put in drum
- Butterwash started

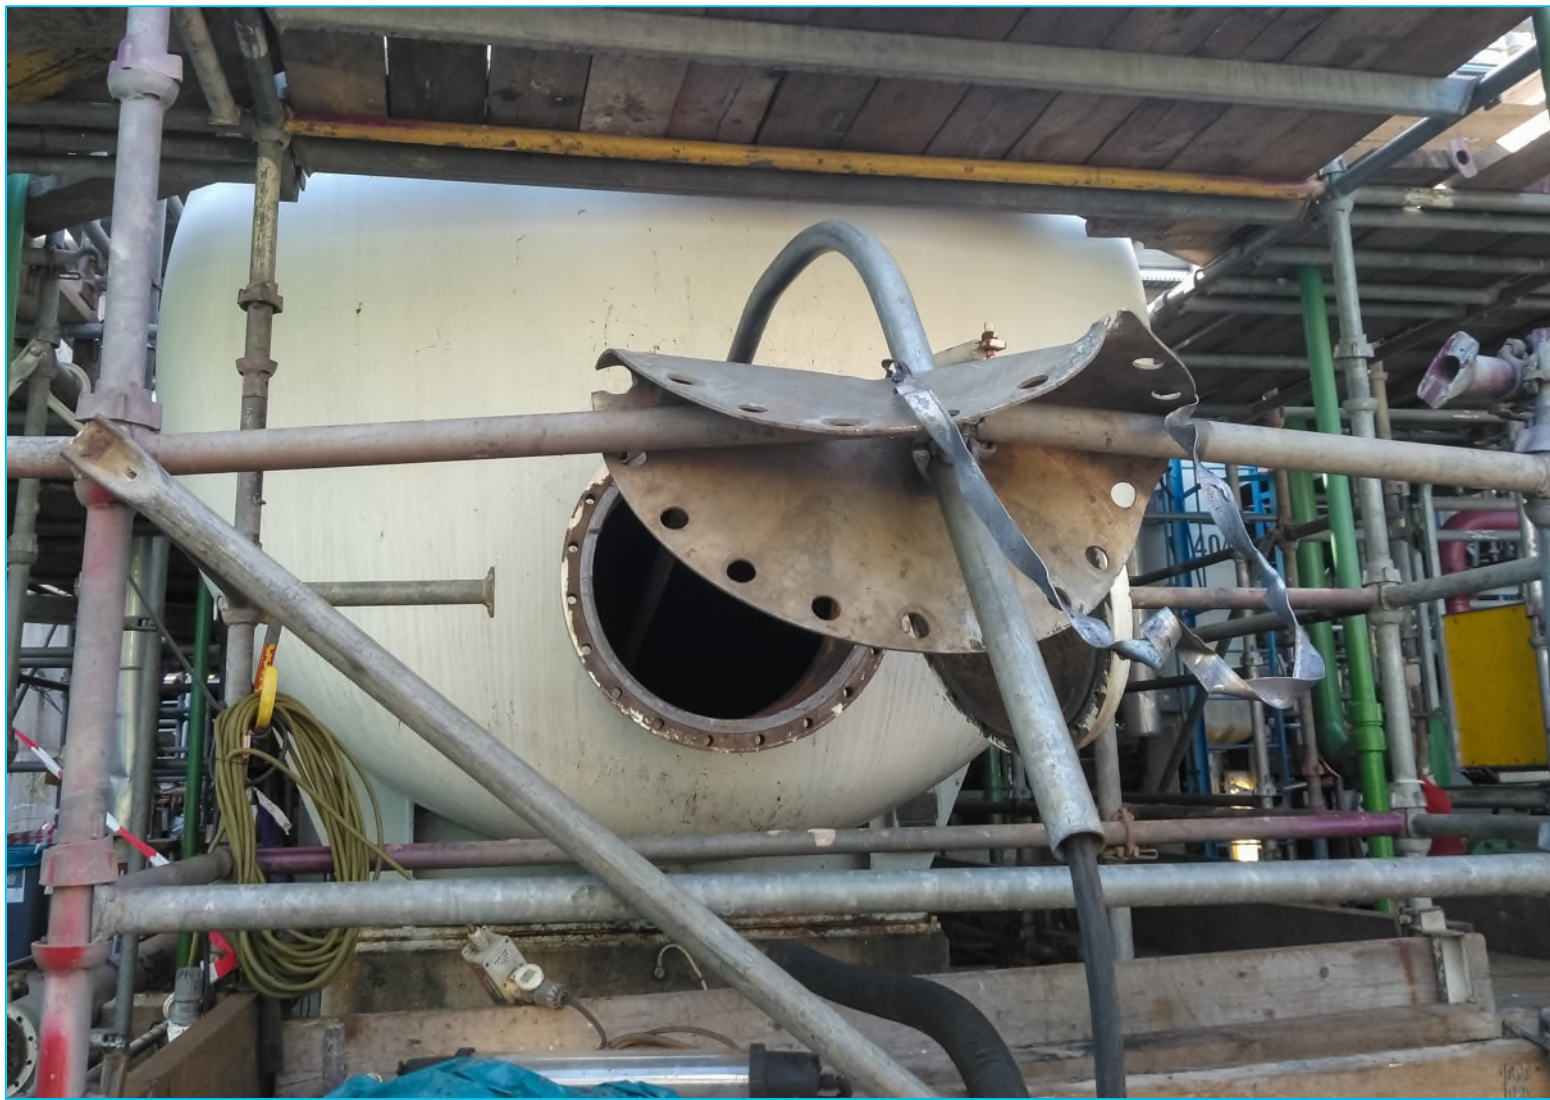
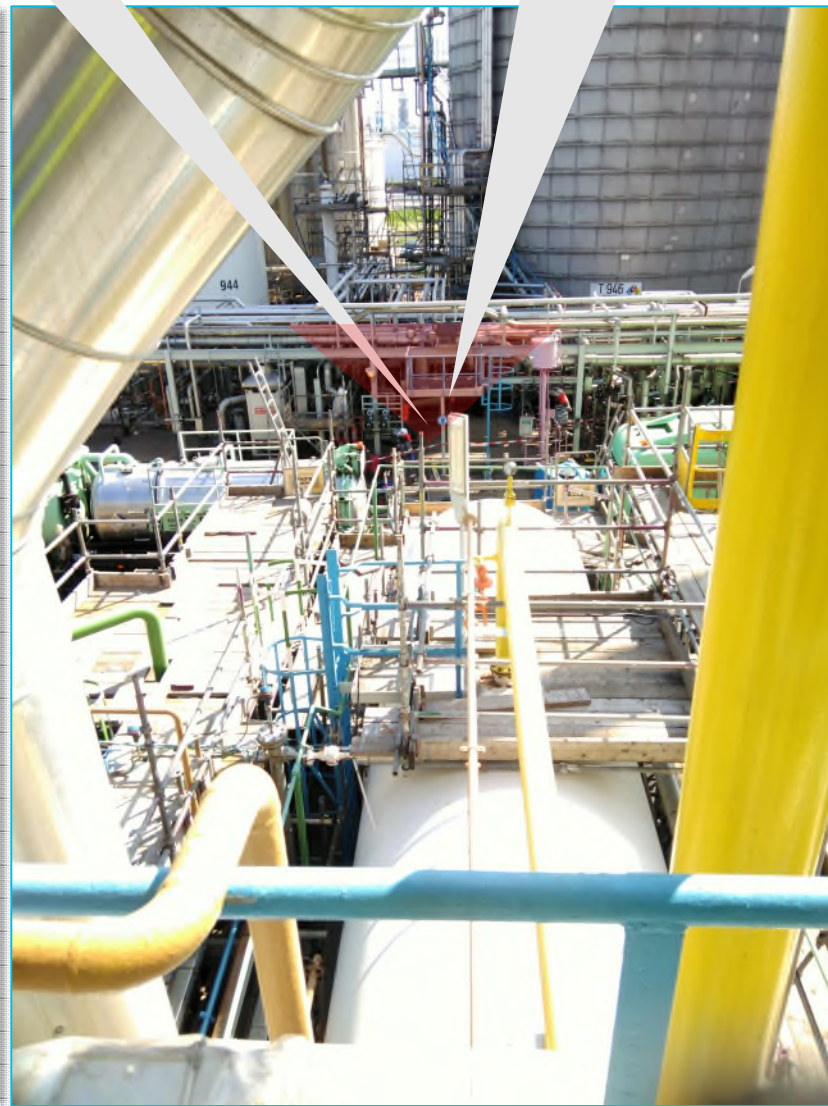
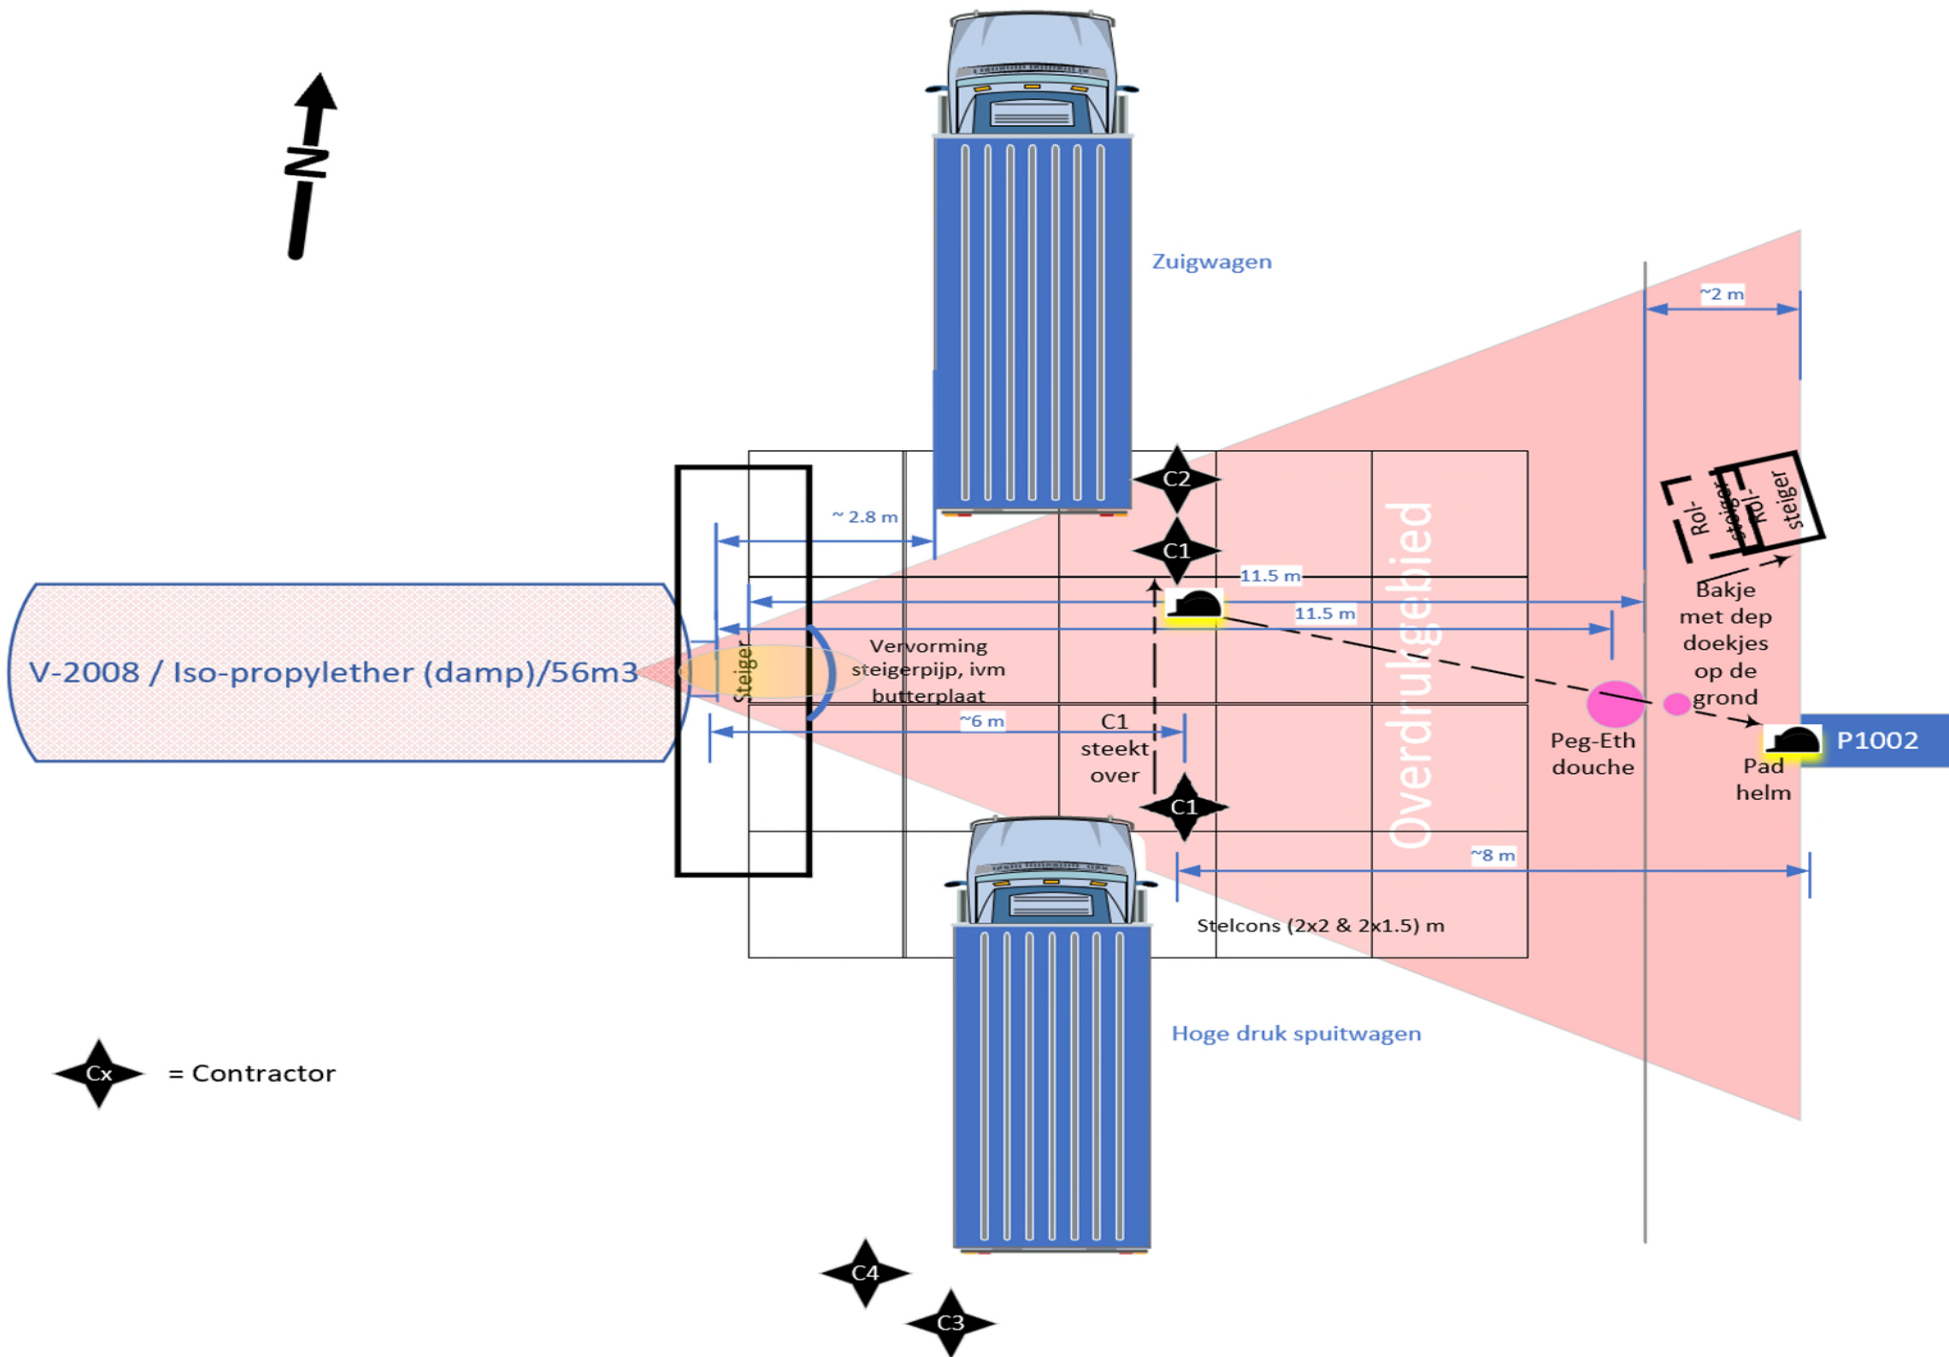
Moment of explosion

- After 15 minutes loud 'bang'
- Flame of 4-5 meter was seen
- Butterwash pipe was bent
- Splash plate fully bent over scaffolding pipe
- Hard hat blown from head contractor
- Two PE drain drums under nozzle fell down/blew away
- Rolling scaffold damaged pipe insulation

*Pressure wave ext.
(between ~1-25
mbarg)*

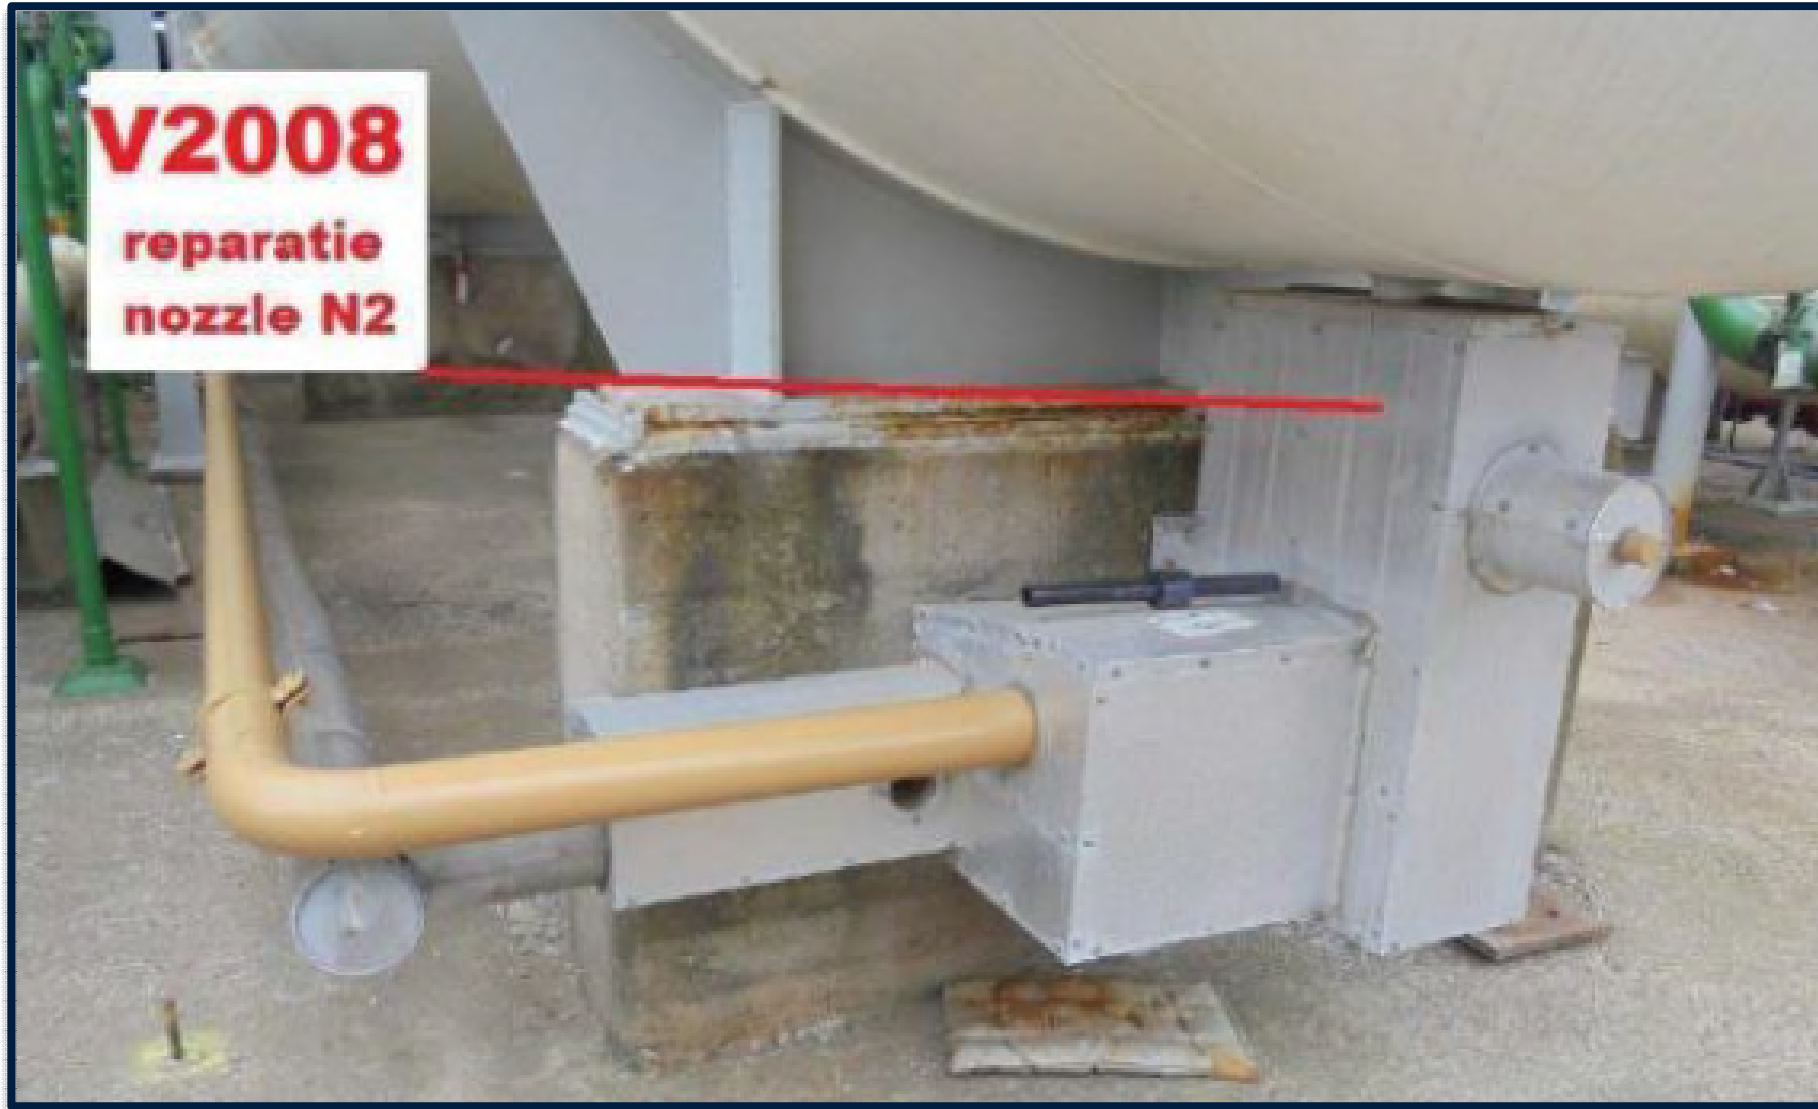
Operational work prior to cleaning

- Remove insulation locally
- Pump out content
- Apply LOTO
- Flush and steam out
- Remove connected piping

Initially ~2 m³ of liquid IPE remained behind, but was removed at a later stage (after steam out)

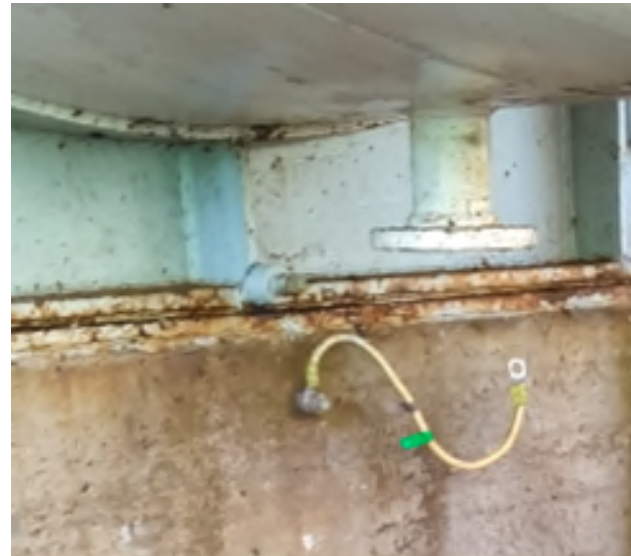
- Vessel: 2 **loose earthing cables**, assumed subject theft -> resistivity tested afterwards, not a cause
- **Peroxides**

- IPE -> Peroxides -> crystals
- Contractor: *A thin layer of residue was found in the vessel prior to butterwash, but no liquid*
